Victoria Beach Field Observations and Recommendations Lake Winnipeg, Manitoba

December 12, 2011
11930.101

Rural Municipality of Victoria Beach

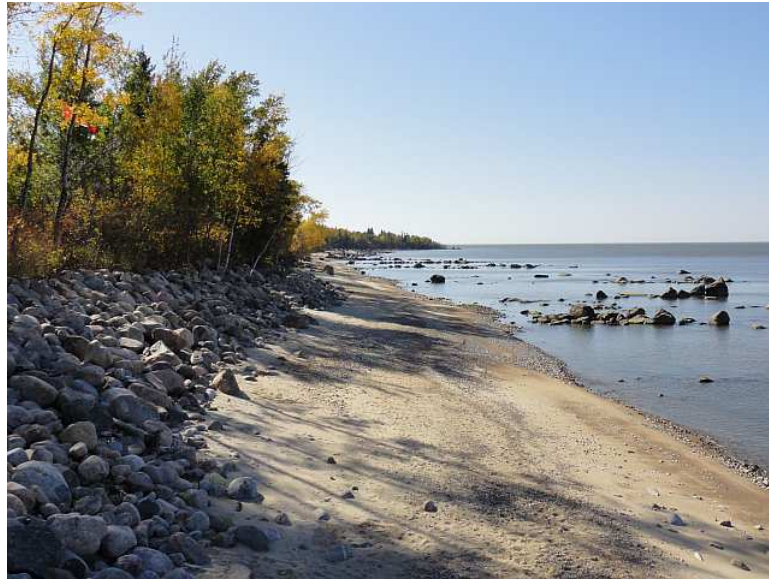
Connaught Beach is located along the north-west shoreline of the peninsula and actively eroding. The angle of the beach appears to be in alignment with the incident waves from the north-west, suggesting it is a wave cut shore (i.e. an erosional feature). Some revetment protection has been installed in the northern end (see Figure 3.2), near the water intake facility. Historically, large cobbles and boulders were piled into shore perpendicular groynes (Figure 3.3).

Figure 3.2 North Section of Connaught Beach Protected with a Revetment

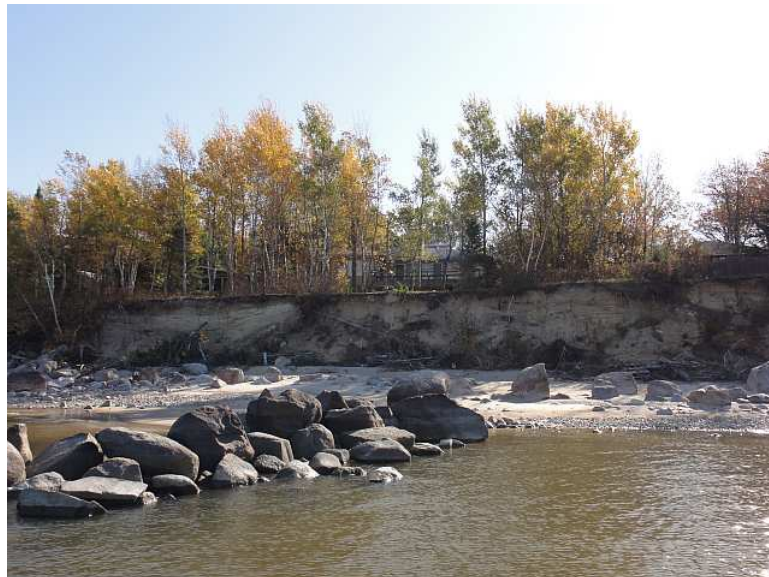
Figure 3.3 South Section of Connaught Beach Featuring Eroding Sandy Bank

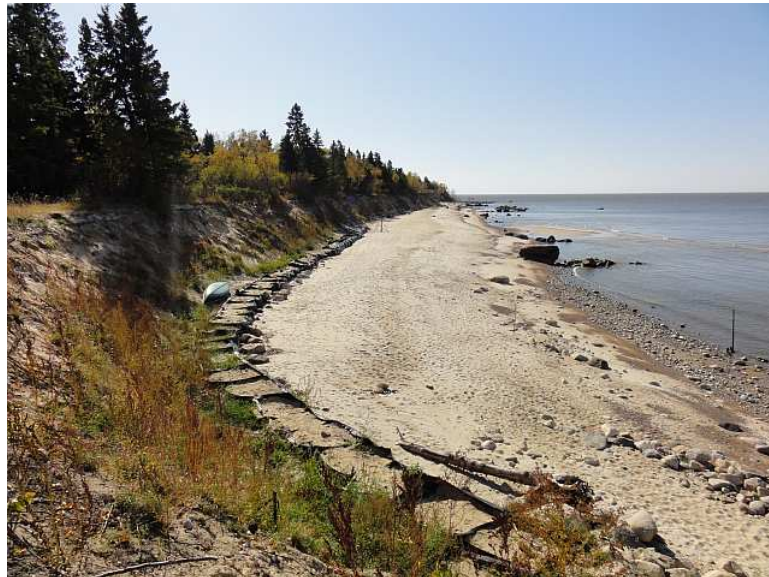
King Edward Beach is located along the west shore of the RMVB and the beach is accessed from a wooden stairwell. See Figure 3.4. The headland to the north of the staircase was armoured in the past and was just recently upgraded with additional stone. Along the toe of the eroding sand bank at King Edward, geo-textile sand bags were placed to provide temporary protection from bank erosion during high lake levels.

Figure 3.5 Geo-textile Sand Bags Placed at the Toe of the Bank

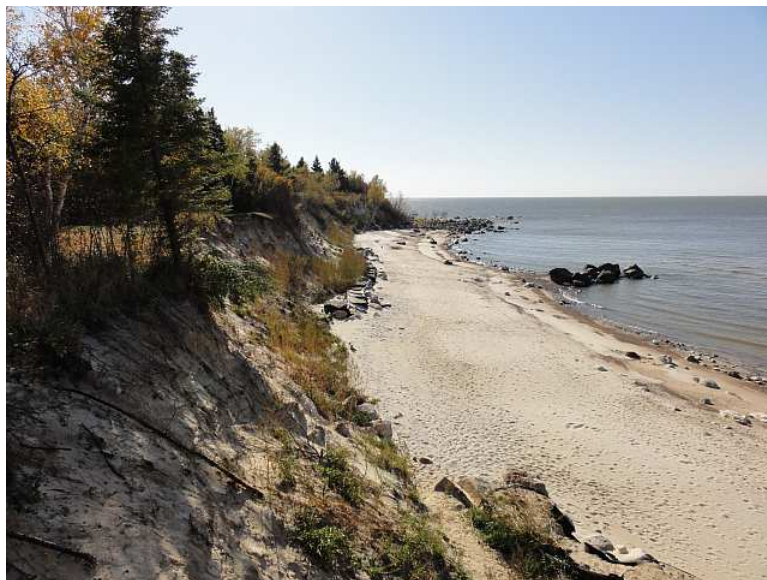
Alexandra Beach is adjacent to King Edward and access to the beach from the high sand bank is provided by a wooden staircase (Figure 3.6). The base of the staircase was also protected with the geo-textile sand bags. In several locations large boulders have been rearranged to form ad hoc shore perpendicular shore protection, such as the groyne in Figure 3.7.

Figure 3.7 Eroding Sand Bank at Alexandra Beach

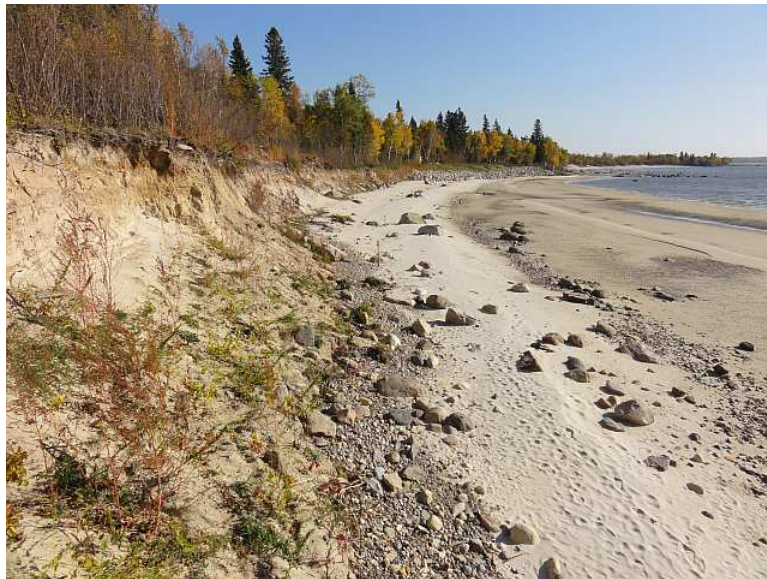
Patricia Beach is located at the base of a high eroding sand bank. The northern limits of the beach are seen in Figure 3.8. A groyne type structure was installed in the past and it appears some ad hoc shore protection is located at the back of the beach. The beach features a very gentle slope and a wide swath of the nearshore was exposed in Figure 3.9 on October 5, 2011 due to the offshore winds and setdown of the lake surface.

Figure 3.9 Eroding Sand Banks at Patricia Looking to the South

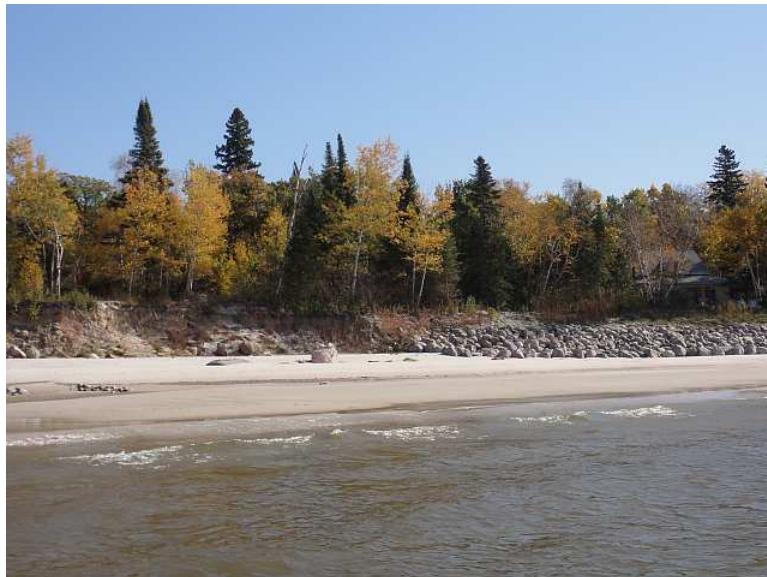
A revetment was recently constructed at the toe of the eroding bank at Arthur Beach, as seen in Figure 3.10. The transition from the revetment to the natural sand bank is seen from the water in Figure 3.11. Remnants of former shore protection was observed further south.

Figure 3.11 Transition from Natural Eroding Bank to Recent Revetment Shore Protection

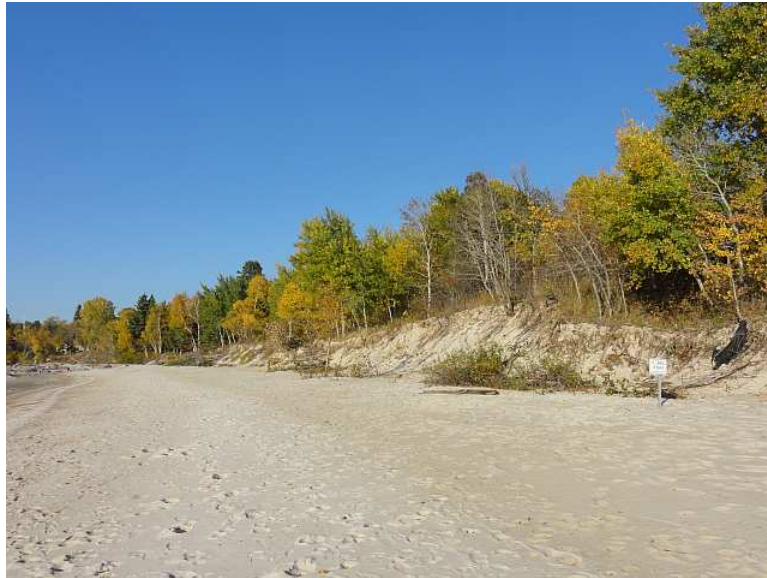
Club House Beach is bounded by Arthur to the north and the municipal pier to the south. The beach is aligned in a north-south direction and possibly backed by relic sand dunes. Due to the gentle slope of the upland, pedestrian traffic is contributing to slope instability. The municipal pier likely helps anchor the southern portion of the beach.

Figure 3.12 Eroding Sand Banks and Beach at Club House

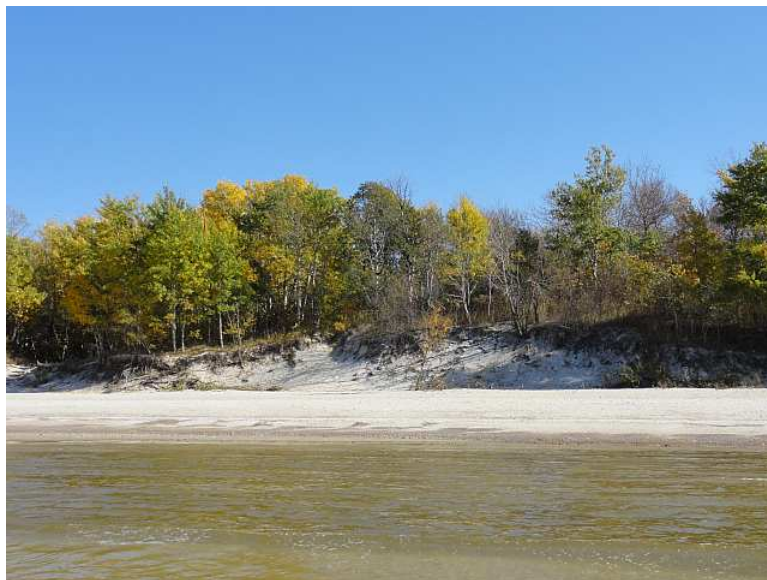
Figure 3.13 View of Eroding Relic Sand Dunes at Club House

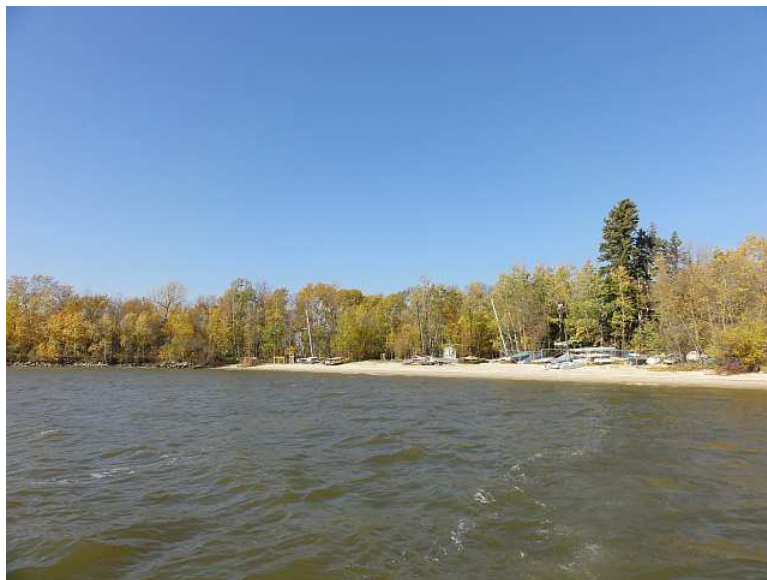
Bayview is located in the lee of the municipal pier and features a narrow sand beach. A boating club is located on the beach, as seen in Figure 3.14. The sand beach transitions to shore protect towards the pier, as noted in Figure 3.15. Although the beach is somewhat sheltered from wave attack on the main lake, sediment supply is also limited due to the presence of the pier.

Figure 3.15 Transition from Sand Beach to Shore Protection on Bayview

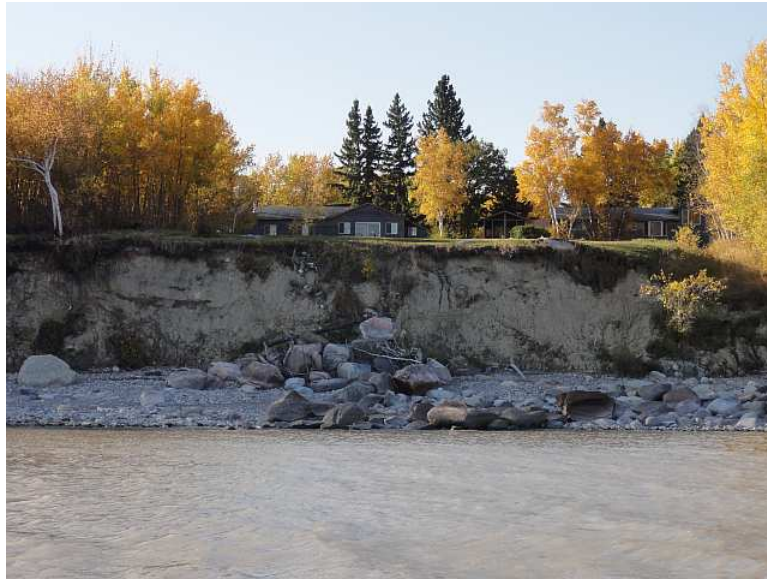
The south-east boundary of the municipality is defined by Saffie Road. The eroding bluffs appear to cut in a glacial till with a high cobble/boulder content and low percentage of sand. Refer to Figure 3.20. The backshore is protected by a combination of dumped boulders and gabion baskets. Given the general shoreline orientation of this area and lack of sand in the bank, it is unlikely sand beaches exist here, even during low lake levels.

Figure 3.20 Eroding Glacial Till (?) Bluff along Saffie Road

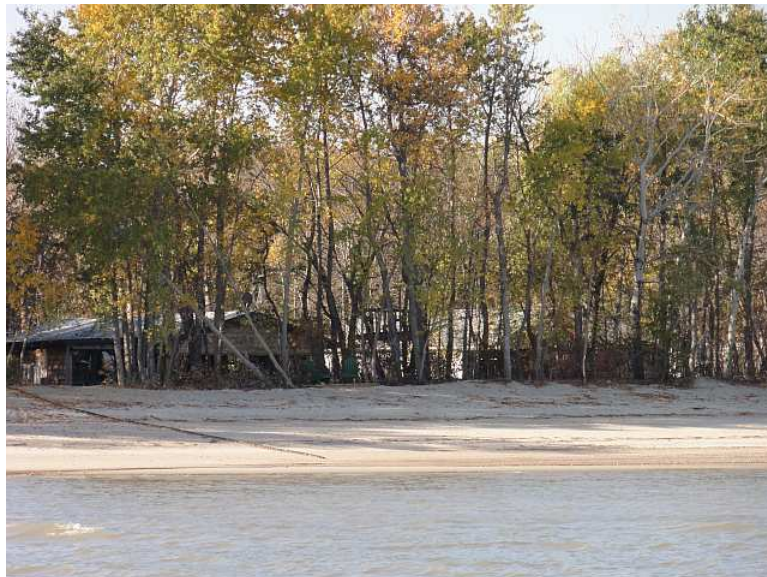
Albert Beach is located north-west of Saffie Road and is generally unprotected. The bank height decreases as you move towards the causeway. Since the back of the beach has remained unprotected, a wide beach remains. Refer to Figure 3.22. Due to the low elevation of the backshore, a sand bank dyke was constructed at the back of the beach to protect the residential/cottage development.

Figure 3.23 Flood Susceptible Development behind Albert Beach

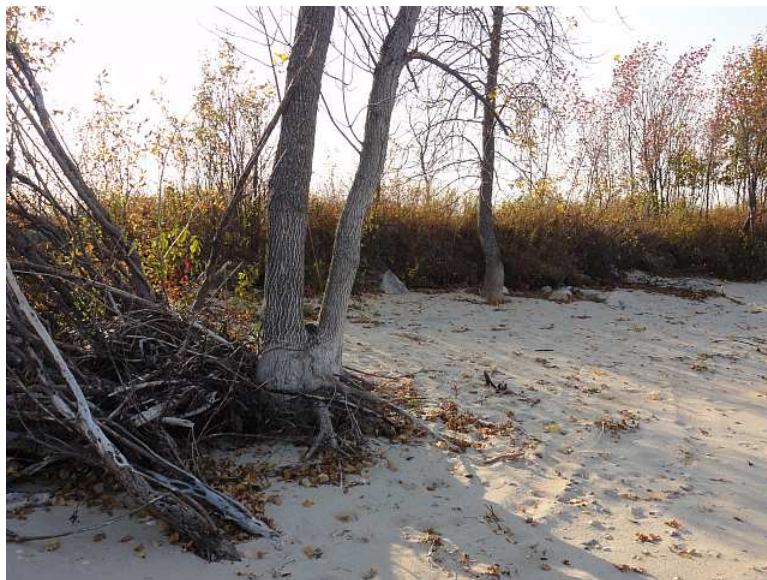
The Causeway is a narrow strip of beach that separates Lake Winnipeg from Highway 59. Although this area features a sand beach, the shoreline has been heavily modified by structures in the past. Refer to the former piles in Figure 3.24 from a former Lumber Mill. Exposed tree roots in the backshore, as seen in Figure 3.25, suggest the beach is eroding.

Figure 3.25 Exposed Tree Roots in the Backshore Indicate the Beach is Eroding

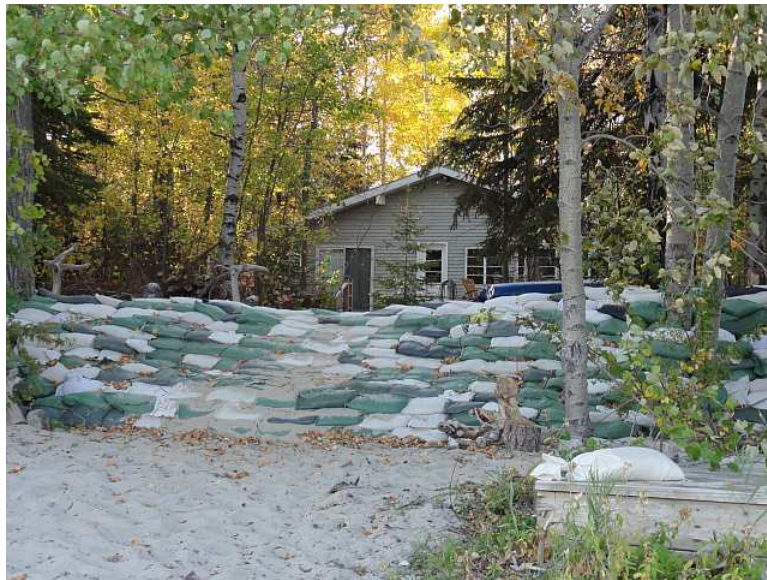
Wanasing features a combination of sand and cobble/pebble beaches. See Figure 3.26. Due to the low elevations of the backshore, a sand bag dyke was recently constructed to provide additional flood protection (Figure 3.27). The beach features a wide variety of structures, from boulder groynes, gabion groynes and boat docks.

Figure 3.27 Sand Bag Dyke Protecting Flood Susceptible Homes

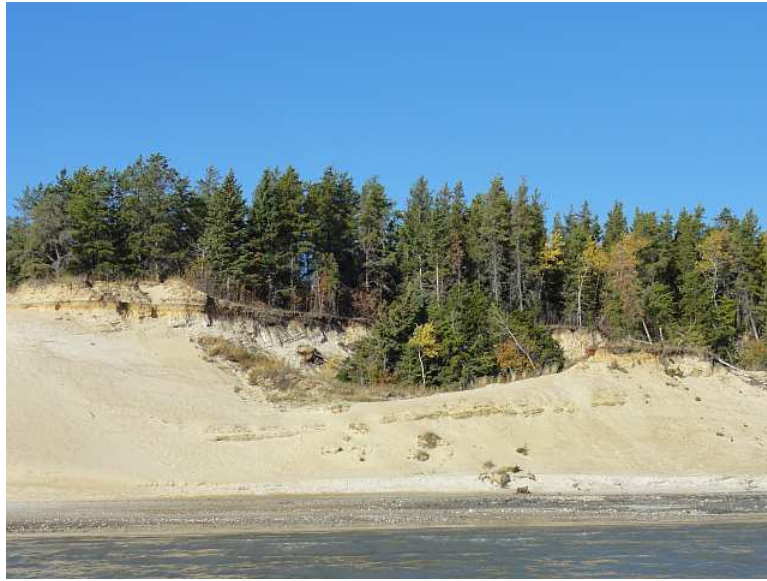
The Sand Bluffs are actively eroding and evidence of massive slope failures was observed in the field. Refer to Figure 3.28, where a portion of the tablelands was displaced following a large rotational failure. Although the majority of the bluffs are sandy, clay lenses were observed at higher elevations and on the beach, as seen in Figure 3.29. The clay lenses can create perched water tables in the bluff, creating ideal conditions for a rotational failure.

Figure 3.28 Large Rotational Failure in Sand Bluff

- **Interim Development Restrictions:** Until updated shoreline regulations have been developed, new construction or home additions along the shoreline should not be permitted. Further, for the areas featuring a high eroding coastal bluff (such as east shore), a geo-technical slope stability analysis is recommended to evaluate the risk of future rotational slope failures; and
- **Ongoing - Continued Stakeholder Participation:** The local shoreline stakeholder committee provides a critical liaison role between the residents of Victoria Beach and the Municipality. Their continued involvement will ensure all the views of the local stakeholders are heard and considered when developing long-term management options for the shoreline.

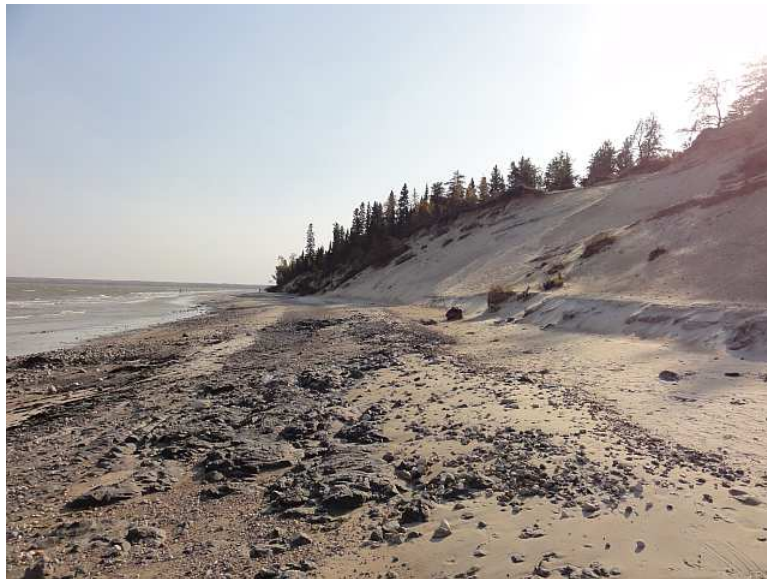
Figure 3.29 Exposed Clay on the Beach at Sand Bluffs

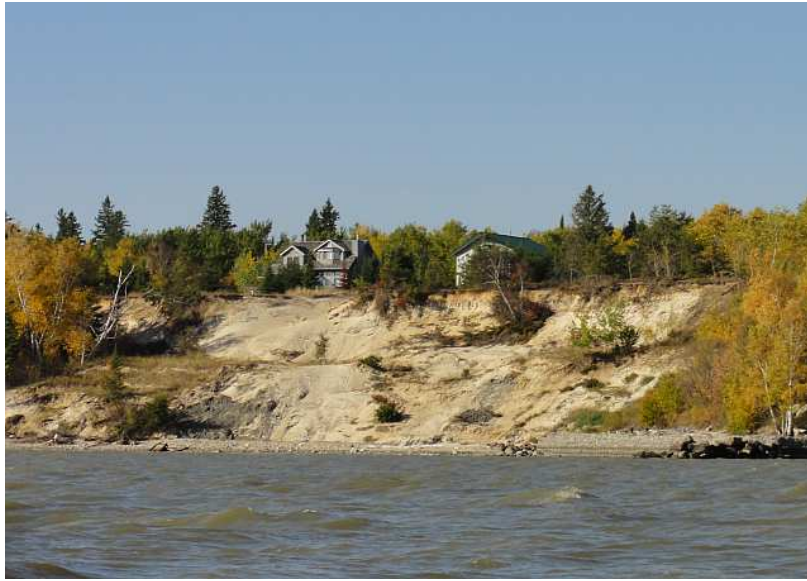
Sunrise features similar geologic conditions (very high sandy bluffs) to Sand Bluffs. It was distinguished as a separate study area due to the presence of the residential development as seen in Figure 3.30. It appears a large rotational failure also impacted this stretch of shore and future slope failures might have serious consequences for the existing development. A bluff stability assessment should be performed to evaluate the risks of future failures. Some areas are protected (Figure 3.31).

Figure 3.30 High Sand Bank with (potential) Rotational Failure

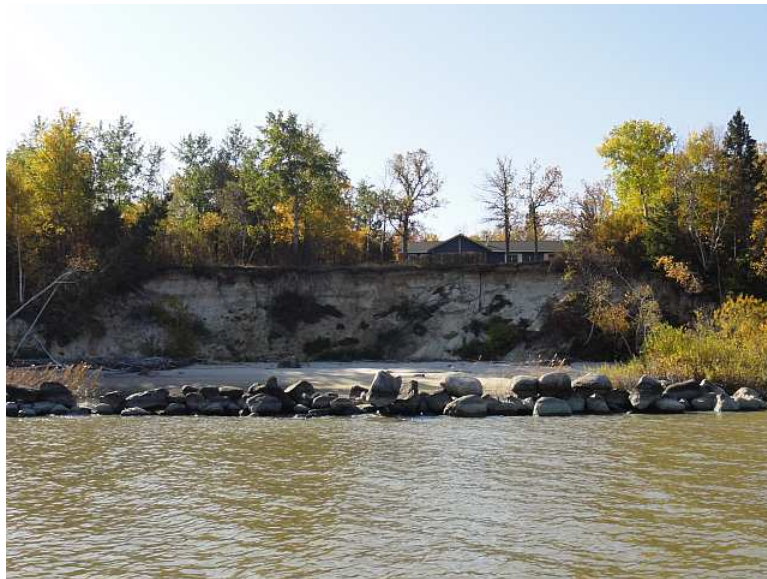
The Hampton peninsula is located in the north-east corner of the municipality. Development densities are not as dense as most other shoreline segments. Although the shoreline orientation is not conducive to beach building, the natural sections of shore are stable (see Figure 3.32). Conversely, when the forest vegetation has been removed for development, a steep eroding bank is present at the back of the beach, as seen in Figure 3.33.

Figure 3.33 Eroding Sand Bank Where Vegetation Cleared for a Residential Lot

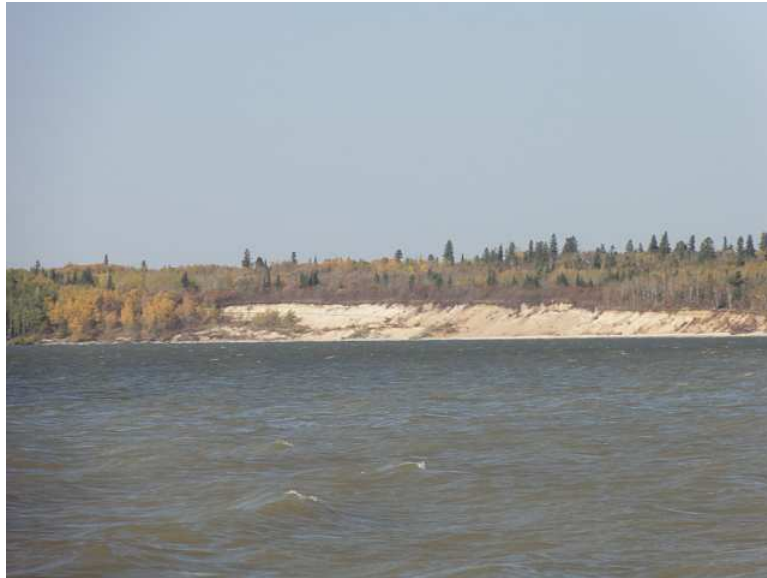
The southern shoreline of Elk Island Provincial Park and the sand spit were observed from the boat. A view of the south-west shoreline is seen in Figure 3.38 and it looks very similar to the Sand Bluffs site. This eroding sand bluff is a potential source of beach sand for the western shore of the RMVB. The sand spit at the southern tip of the island is a popular locations for shore birds (see Figure 3.39).

Figure 3.38 Eroding South-western Shore of Elk Island
