Rural Municipality of Victoria Beach Shoreline Management Plan Lake Winnipeg, Manitoba

February 7, 2014
11930.201

Rural Municipality of Victoria Beach Shoreline Management Plan

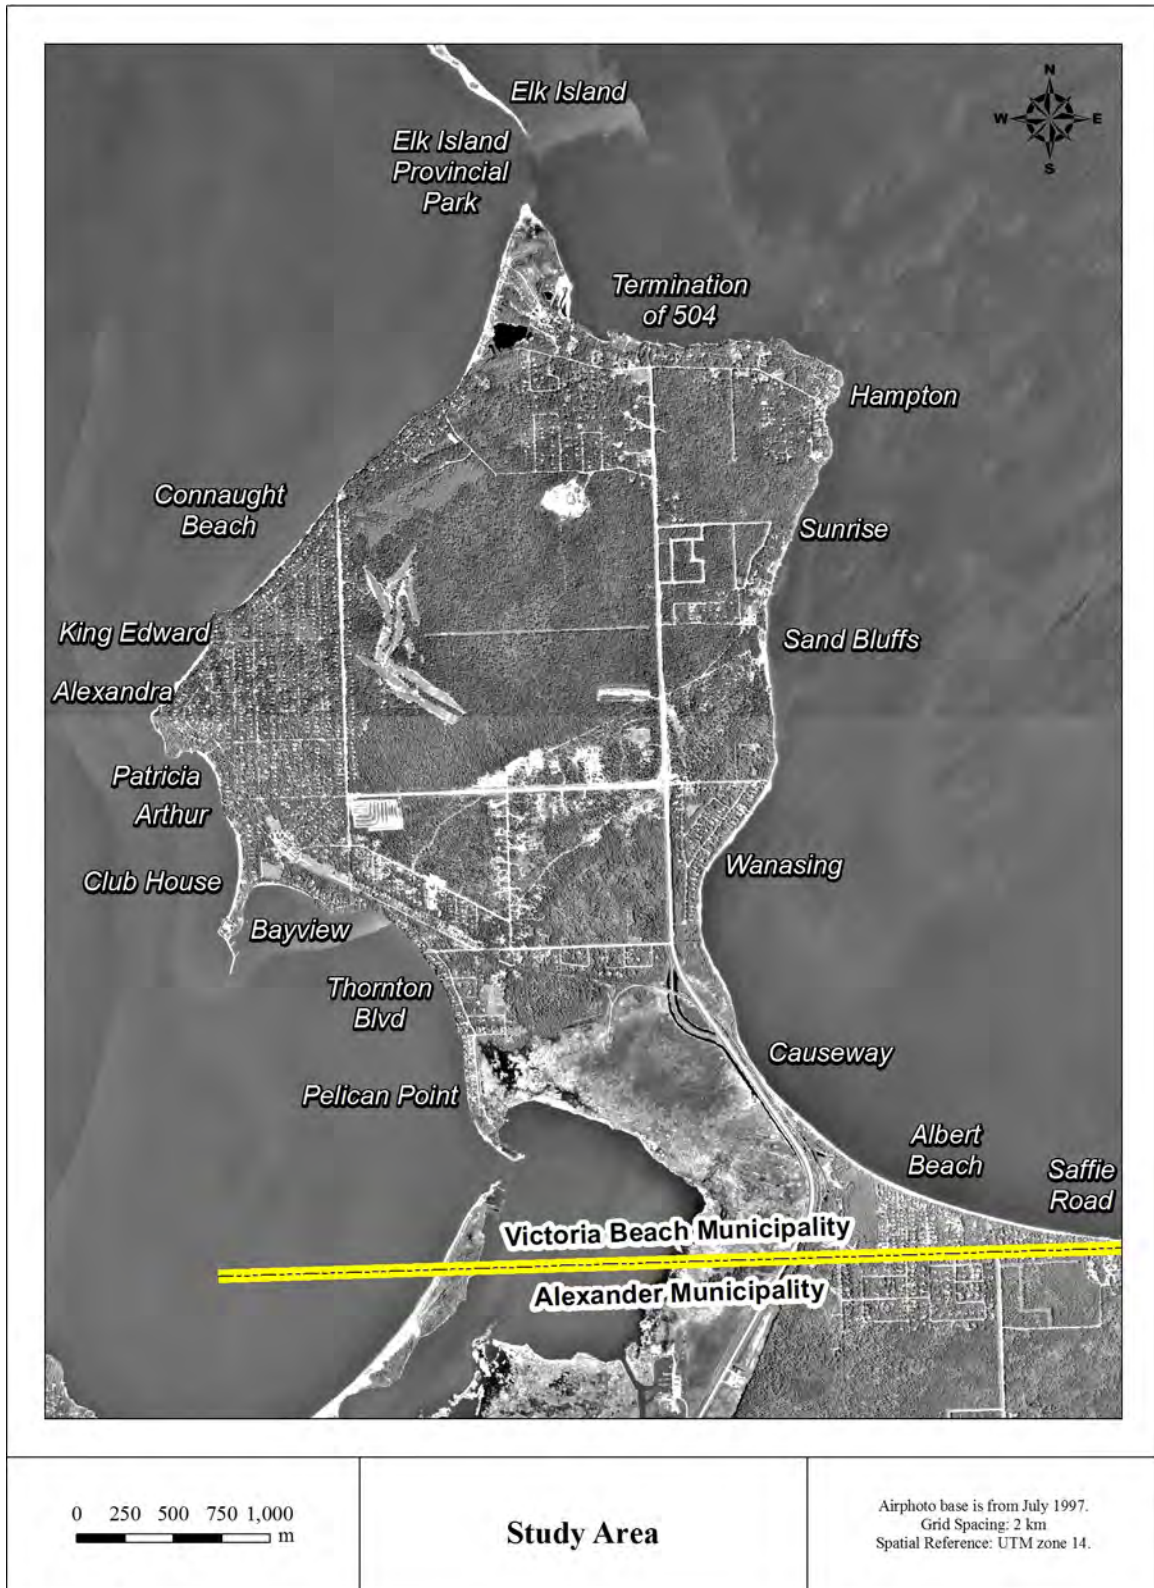
Figure 1.1 Study Area

The RMVB is a small peninsula located in the southern basin of Lake Winnipeg (refer to Figure 1.1). Elk Island is located immediately north of the RMVB and separated by a shallow water sand spit. During low lake levels an isthmus exists that connects Victoria Beach to Elk Island.

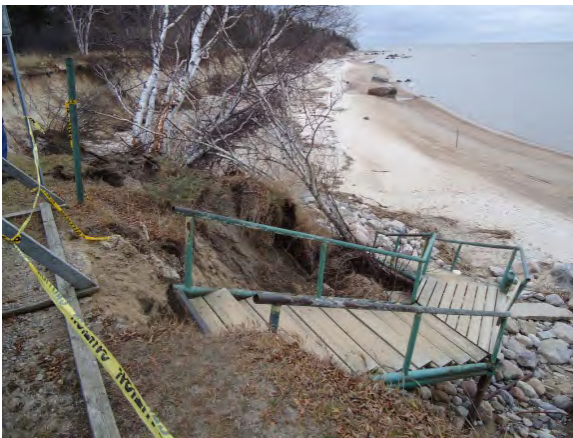
**Figure 1.2 King Edward Beach
Fall 2010 after “weather bomb”**

On October 27, 2010, there was a storm event with strong NNW winds that persisted for most of the day when the lake was already at a high level. This storm caused significant erosion around the shoreline of Victoria Beach, and is locally referred to as the “weather bomb”. It was this “weather bomb” that raised awareness about the coastal erosion hazards and ultimately initiated the development of the SMP. Some examples of the erosion as a result of this storm are shown in Figure 1.2 through to Figure 1.5.

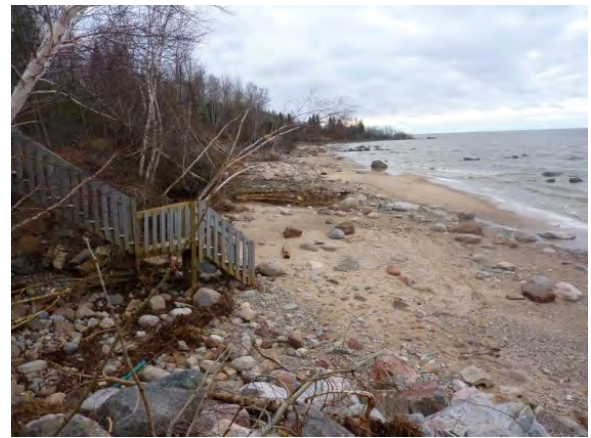
**Figure 1.3 Connaught Beach
Fall 2010 after “weather bomb”**

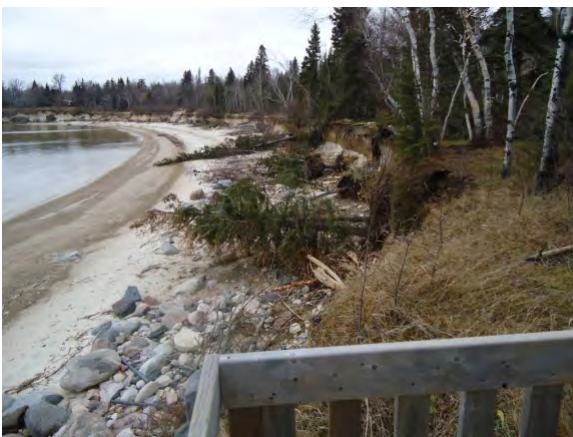
**Figure 1.4 Arthur Beach
Fall 2010 after “weather bomb”**

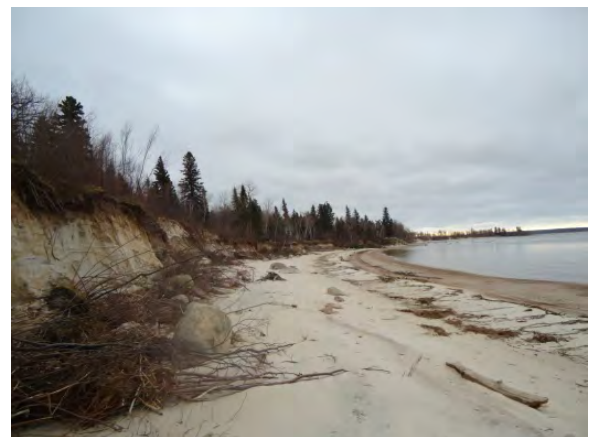
**Figure 1.5 Patricia Beach
Fall 2010 after “weather bomb”**

During the storm event in October 2010, the 24 hour average wind speed at the Victoria Beach gauge was 17 m/s (61 km/hr) with a maximum recorded hourly wind speed of 19.2 m/s (69 km/hr). The water level at the time of the storm was 219.56 m ASL (720 ft) at the Victoria Beach Gauge (05SA003). To put this water level into context, the high end of the regular operating range of the Lake by Manitoba Hydro is 217.9 m ASL (715 ft). It was predicted by Baird in the Technical Study for the RMVB (in press) that the wave height (Hs) offshore of the project site reached 2.9 m during the peak of the storm.

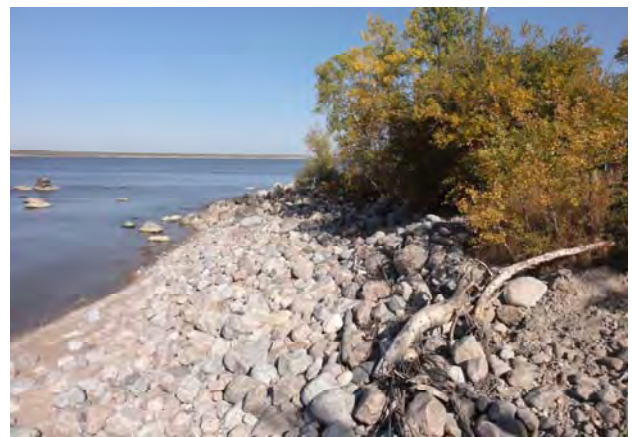
Figure 2.3 North Connaught Beach October 2011

The northern end of Connaught beach is comprised mainly of engineering structures and natural rocks in the nearshore. An example of the type of structures is shown in Figure 2.3.

The top of bank surveyed in 2013 is less than 2 m from the edge of the property parcels for 30% of the reach. However, since the shoreline has been stabilized by existing engineering structures, the risk of additional erosion is expected to be minimal if the existing structure are maintained.

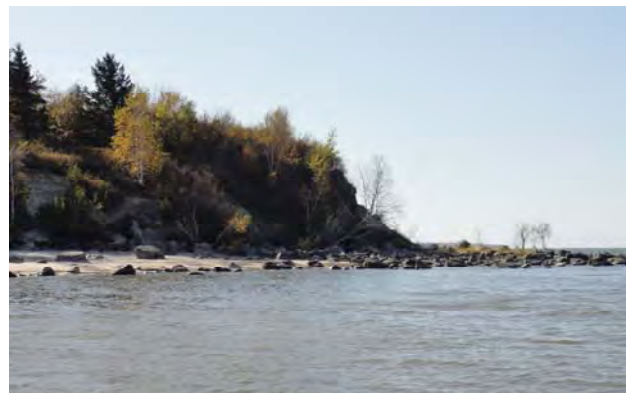
Figure 2.6 Scott Point Headland October 2011

Scott Point is a headland that mainly consists of glacial till as shown in Figure 2.6. Scott Point has been eroding over time at an average rate of about 0.15 m/yr \pm 0.05 m.

The top of bank surveyed in 2013 is more than 30 m from the edge of the property parcels. This reach is therefore at low risk of the shoreline eroding to the lakeward limit of the private property parcels. However, it is municipal park land that is eroding and a long-term erosional mitigation solution may be desirable in the future. Due to the orientation of the shoreline, when the water level is high and there are large waves from the northwest, the sediment is transported to the south.

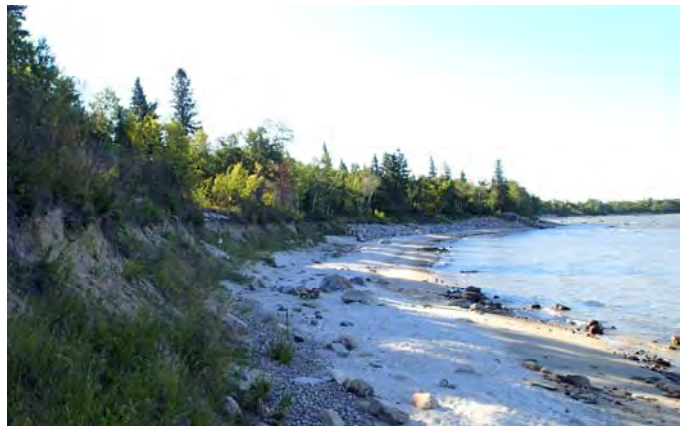
Figure 2.7 Patricia Beach August 2013

Some ad-hoc structures have been placed along the shoreline including some loosely placed rock groynes and a rock revetment at the toe of the bluff near the Arthur stairs.

Due to the orientation of the shoreline, when the water level is high and there are large waves from the northwest, the sand bluffs erode and the sediment is transported towards the south. Storms from the southwest have the potential to transport sand onto Patricia Beach from the nearshore area.

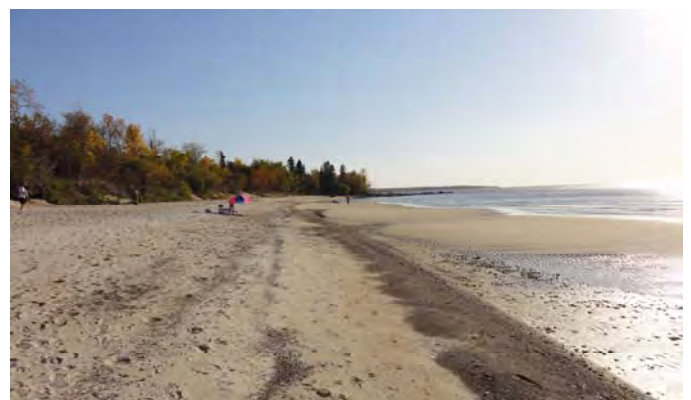
Figure 2.8 Club House Beach October 2011

The southern portion of Reach 5, including Club House Beach, is comprised of a wide sandy beach backed by low sand dunes. A typical site photograph is provided in Figure 2.8.

The top of bank surveyed in 2013 is greater than 10 m from the lakeward edge of the private property parcels. Therefore, this reach is at relatively low risk of shoreline erosion to the edge of the private property parcels.

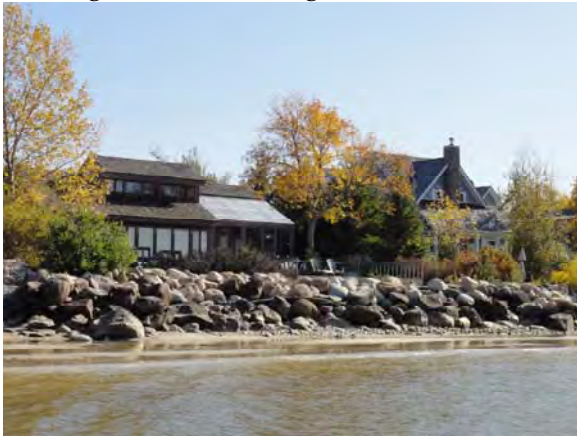
Figure 2.9 Pelican October 2011

The shoreline from Bayview to Pelican Point consists of low banks with extensive shoreline armouring, such as gabions and rock revetments; an example is shown in Figure 2.9. Due to the existing structures along the shoreline, erosion is a low risk. However, due to the relatively low elevation in this area (especially along Pelican Point), it is susceptible to flooding.

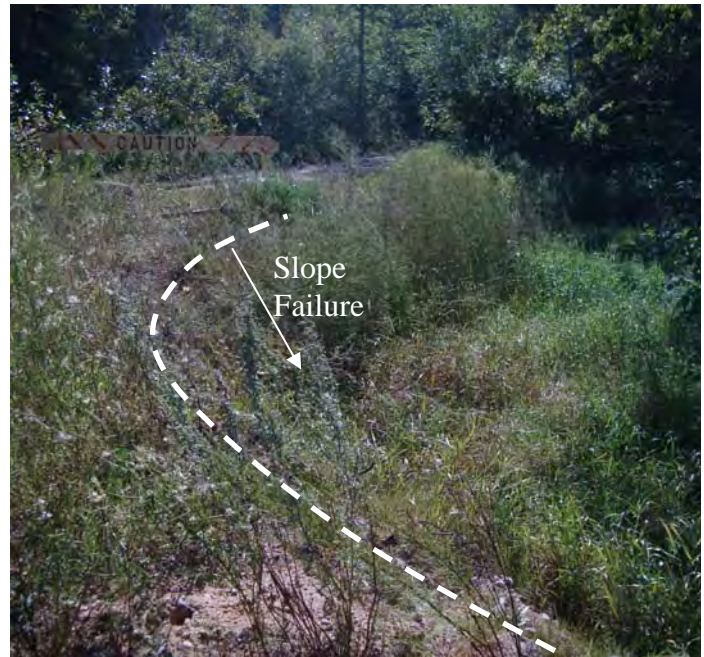
Figure 2.10 Slope Stability Issues off Gibson Drive August 2013

Slope stability issues were observed in August 2013, just off Gibson Drive between 8th Avenue and Thornton Boulevard (across the road from house numbers 40 and 42 Gibson Drive) as shown in Figure 2.10. A geotechnical investigation is required to confirm the cause of the slope failure. However, trees have been up-rooted at the toe of bank from what appears to be a slope failure. There is also a swampy area near the toe of the bank indicating that groundwater may have also contributed to the slope instability.

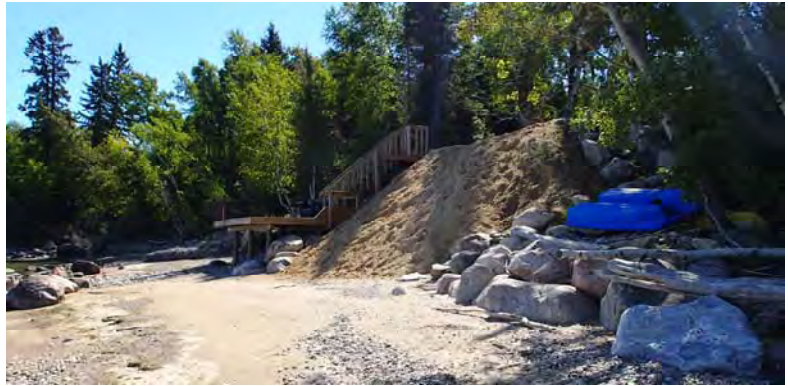
The shoreline from Highway 504 to the Hamptons can be characterised as glacial till bluffs with isolated beach deposits. An example of the reach is shown in Figure 2.11.

Figure 2.11 Shoreline Modifications in Reach 9 August 2013

This stretch of the shoreline has been eroding over time at an average rate of about $0.21 \text{ m/yr} \pm 0.01 \text{ m}$. There is no formal overland drainage infrastructure, and as a result gullies have formed along the shore due surface water flows. The top of bank surveyed in 2013 is within 2 m from the lakeward edge of the private property parcels for about 20% of the reach, and 30% is within 10 m. The lakeward edge of the private property parcels for the remaining 50% of the reach is greater than 10 m from the top of bank. Therefore, this reach is at moderate risk of shoreline erosion to the edge of the private property parcels.

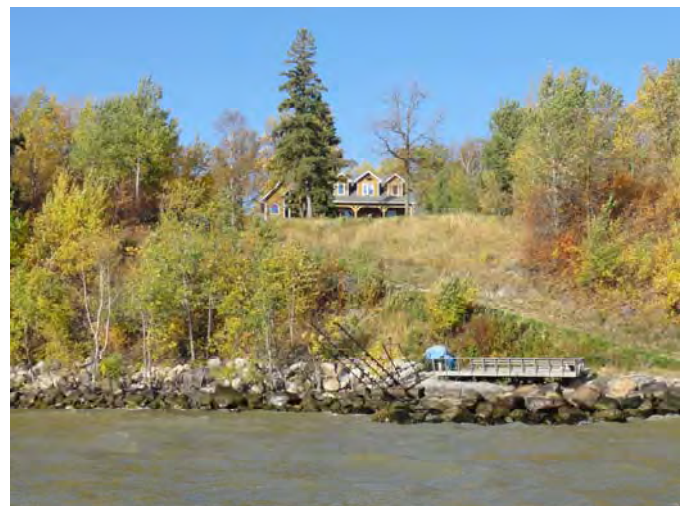
Figure 2.12 Sunrise October 2011

The northern end of the reach consists mainly of engineering structures. A typical site photograph is provided in Figure 2.12. It has been eroding over time at an average rate of about $0.19 \text{ m/yr} \pm 0.05 \text{ m}$. The 2013 top of bank survey is within 2 m of the lake ward edge of about 10% of the private property parcels and the remaining parcels are greater than 20 m. Therefore, there is a relatively low risk of the shoreline eroding to the private property parcels if the existing engineering structures are properly maintained.

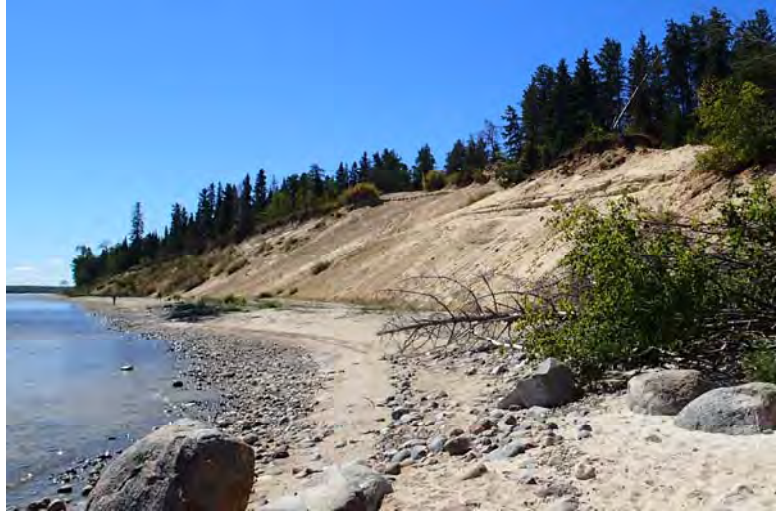
Figure 2.13 Sand Bluffs August 2013

This stretch of the shoreline has been eroding over time at an average rate of about $0.58 \text{ m/yr} \pm 0.11 \text{ m}$. The 2013 top of bank survey is greater than 10 m from the lakeward edge of the private property parcels. However, the Sand Bluffs area shows some signs of large rotational slope failures. Golder Associates Ltd. (Golder) conducted slope inspections on August 7, 2013, as discussed previously in Section 1.4.4. As a result of the geotechnical issues in Reach 10 South, this shoreline is at high risk for additional slope instabilities.

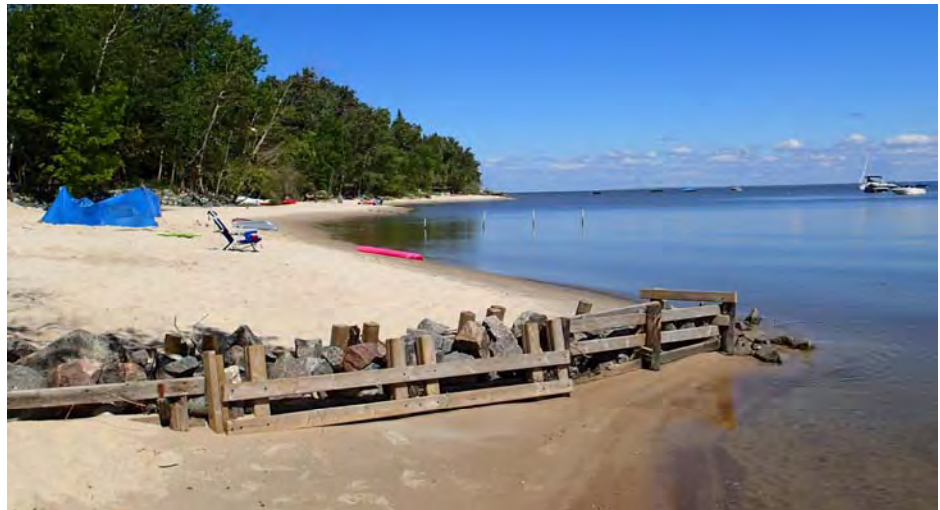
Figure 2.14 Wanasing Beach August 2013

The shoreline from the south of Arthur Road including Wanasing Beach is low lying sandy beach and consequently is susceptible to flooding during storm events at high lake levels. To reduce the risk of flooding and erosion there are numerous ad-hoc structures present along the shore, such as rock gabions, groynes, and sand bag dykes. A typical site photograph is provided in Figure 2.14.

This stretch of shoreline has remained relatively stable overtime due to the existing structures. With the exception of the southern end of the beach where historically there has been some erosion.

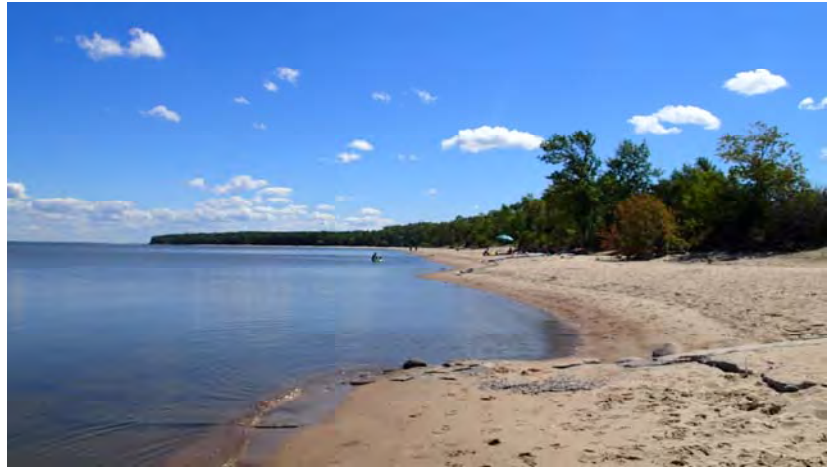
Figure 2.15 Albert Beach August 2013

Albert beach consists of a low lying sandy beach with variable width as shown in Figure 2.15. This reach is susceptible to flooding during storm events at high lake levels. To reduce the risk of flooding, a dyke has been installed at the back of the beach. There is also a rock revetment at the south end of the reach.

The top of bank surveyed in 2013 is within 2 m of the lakeward edge of about 30% of the private property parcels and the remaining parcels are greater than 5 m. This reach is at relatively low risk of shoreline eroding to the property parcels. Since it does not feature a long-term erosion rate, the buildings are at relatively high risk of flooding if the elevation of the sand bag dyke is not maintained in the future.

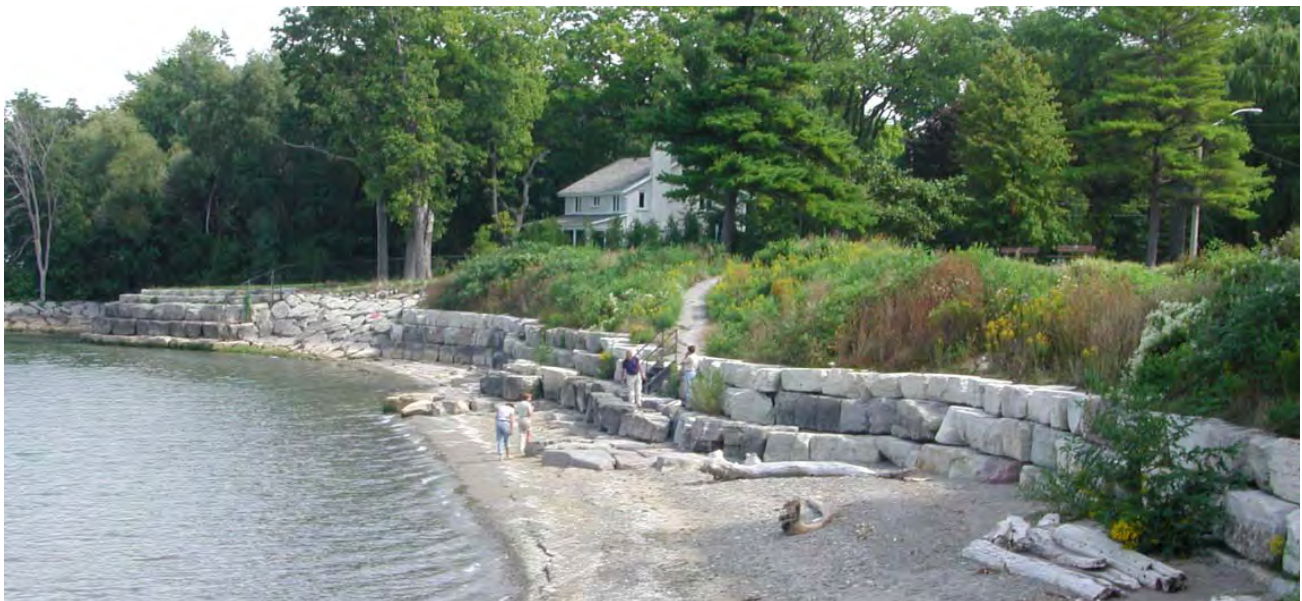
Seawalls are frequently used as shore protection and they may be constructed of cast-in-place concrete, stacked concrete, armour stone blocks (refer to Figure 3.2), stacked gabions or steel sheet piling (refer to Figure 3.3).

Figure 3.2 Example of a Stacked Armour Stone Wall

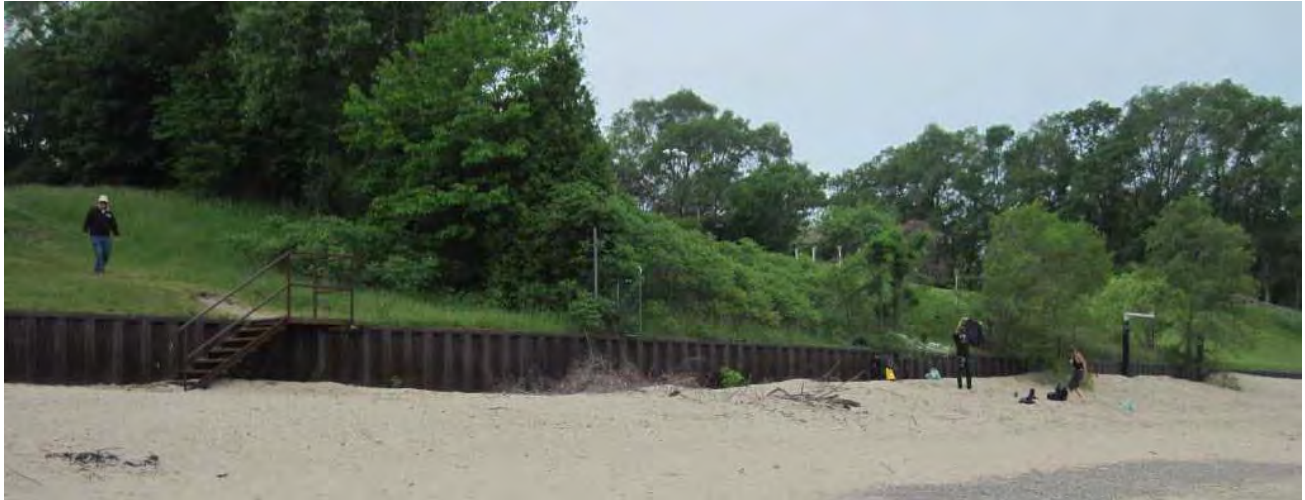
Figure 3.3 Example of Steel Sheet Pile Wall

Stacked stone and block walls must carefully consider the foundation conditions, as they are less flexible than revetments and more prone to collapse due to settlement and undermining. Vertical, impermeable walls (e.g., concrete and steel sheet pile) are generally not recommended due to concerns with wave reflection and scour. Vertical walls are rigid and have much less reserve strength (i.e., ability to withstand wave conditions exceeding the design wave) than armour revetments. Gabion baskets often have a limited life span when used on exposed shorelines and are generally not recommended for use on a water body the size of Lake Winnipeg.

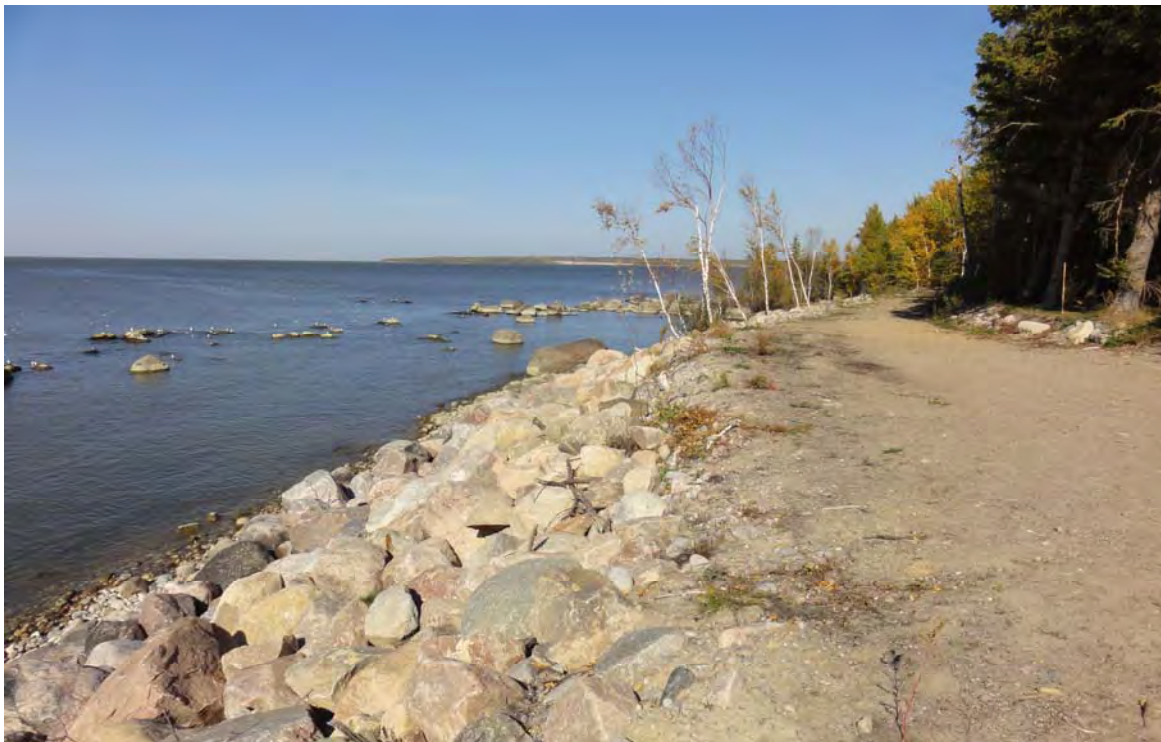
Figure 3.6 Example of Revetment (King Edward)

There are various types of shore parallel structures along the shore of Victoria Beach, including: revetments (refer to Figure 3.6 and Figure 3.7), gabian stacked walls (refer to Figure 3.8), concrete seawalls (Figure 3.9), and sand bag dykes (Figure 3.10). The structures that have been well engineered and constructed have been successful at reducing the long-term erosion rate. Poorly designed and/or constructed revetments, such as the structure in Figure 3.7, will not provide long-term erosion mitigation.

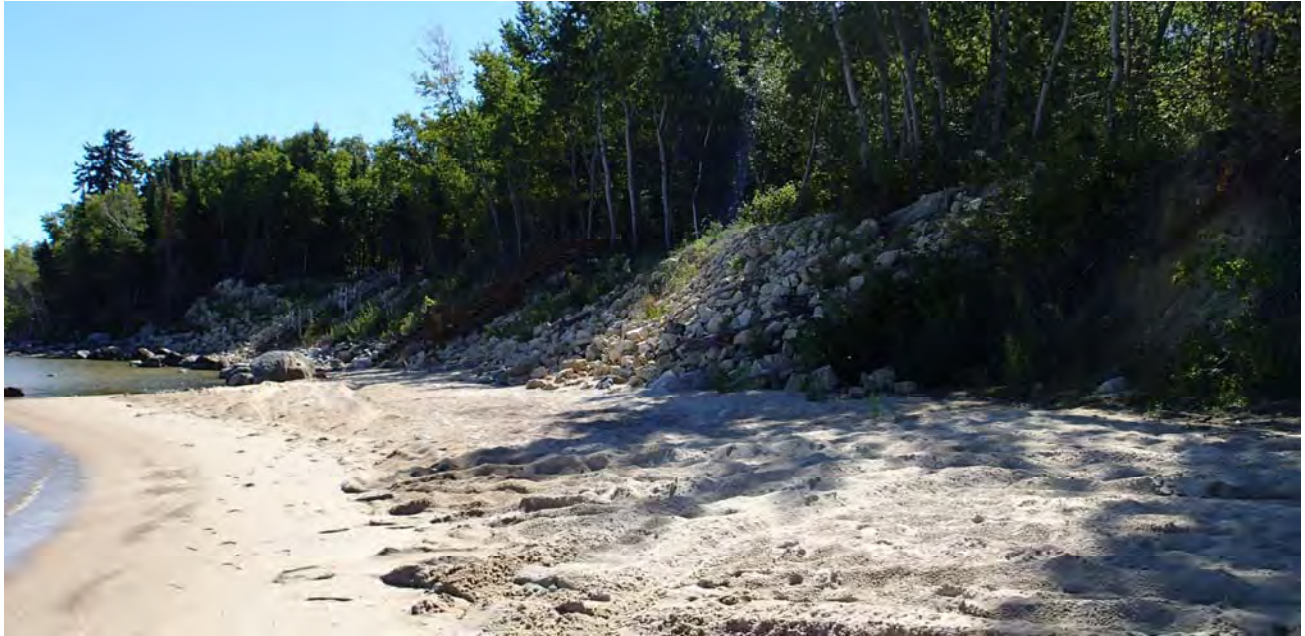
Figure 3.7 Example of Revetment (504 to Hamptons)

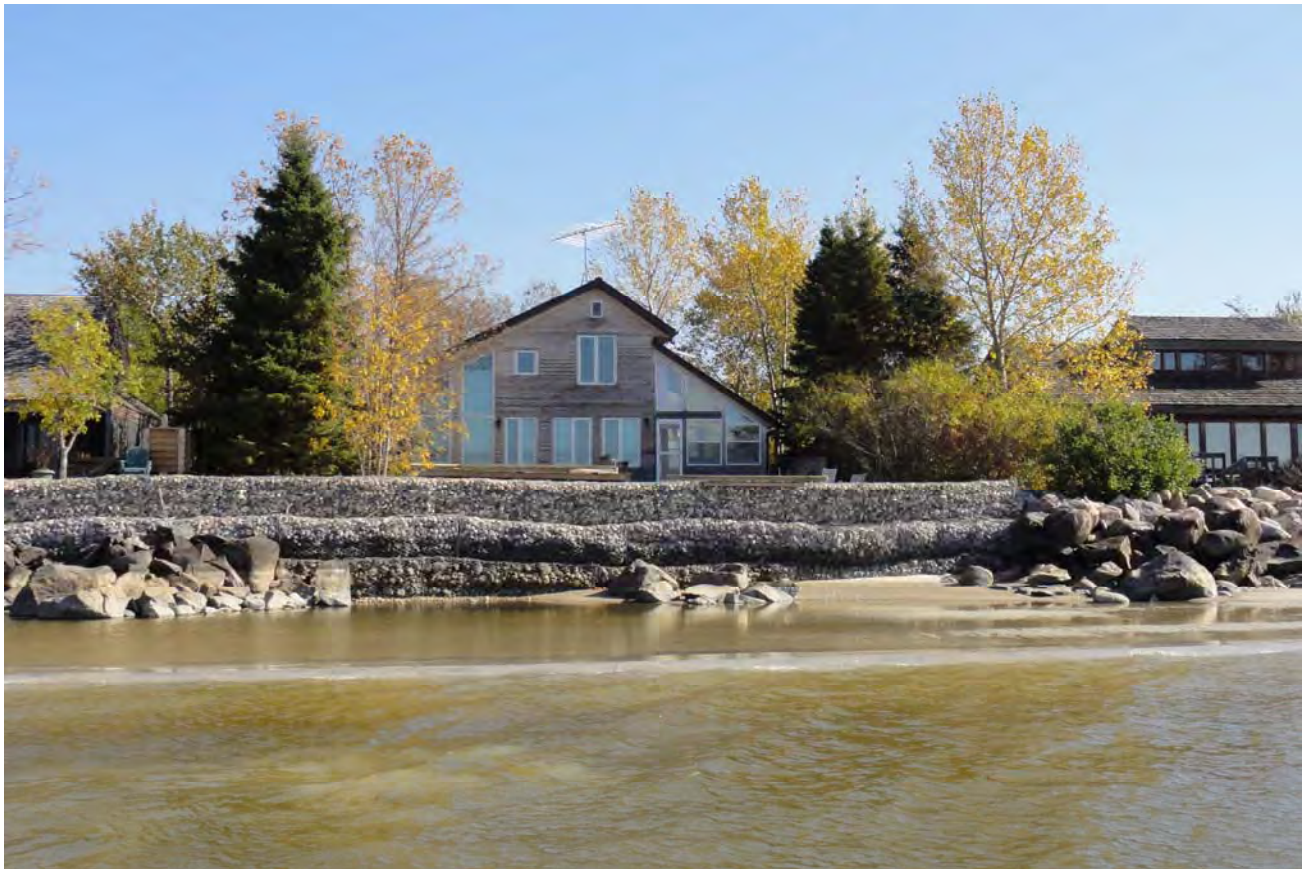
Figure 3.8 Example of Gabion Stacked Wall (Pelican)

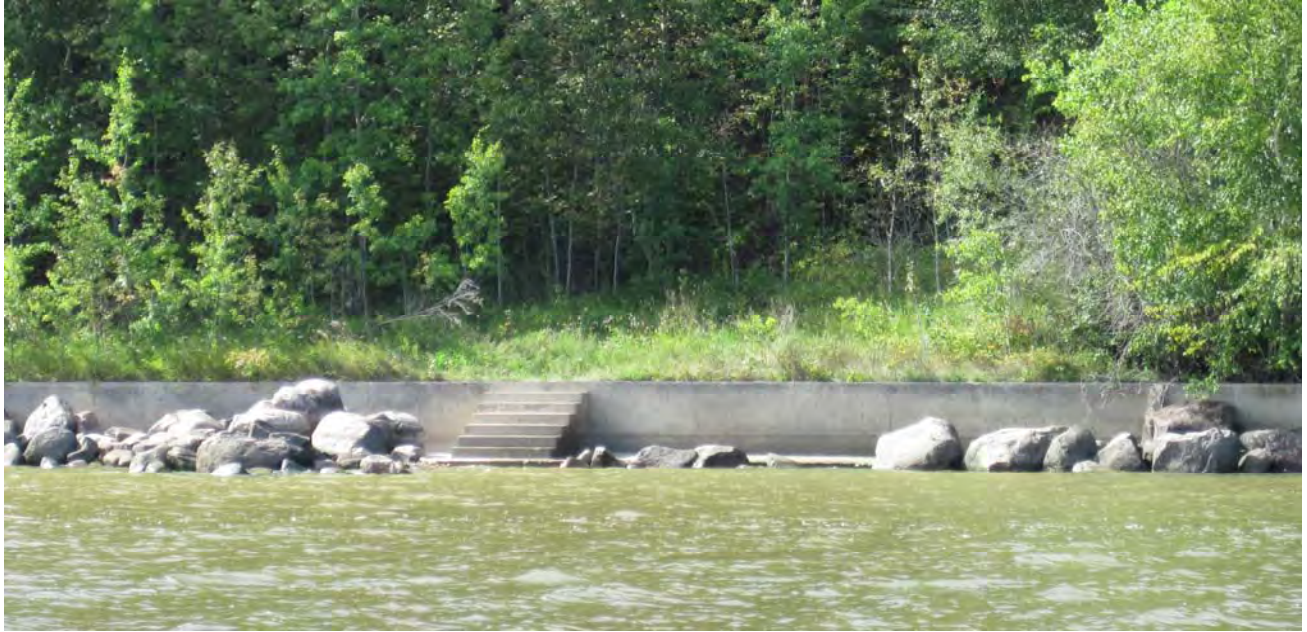
Figure 3.9 Example of Concrete Seawall

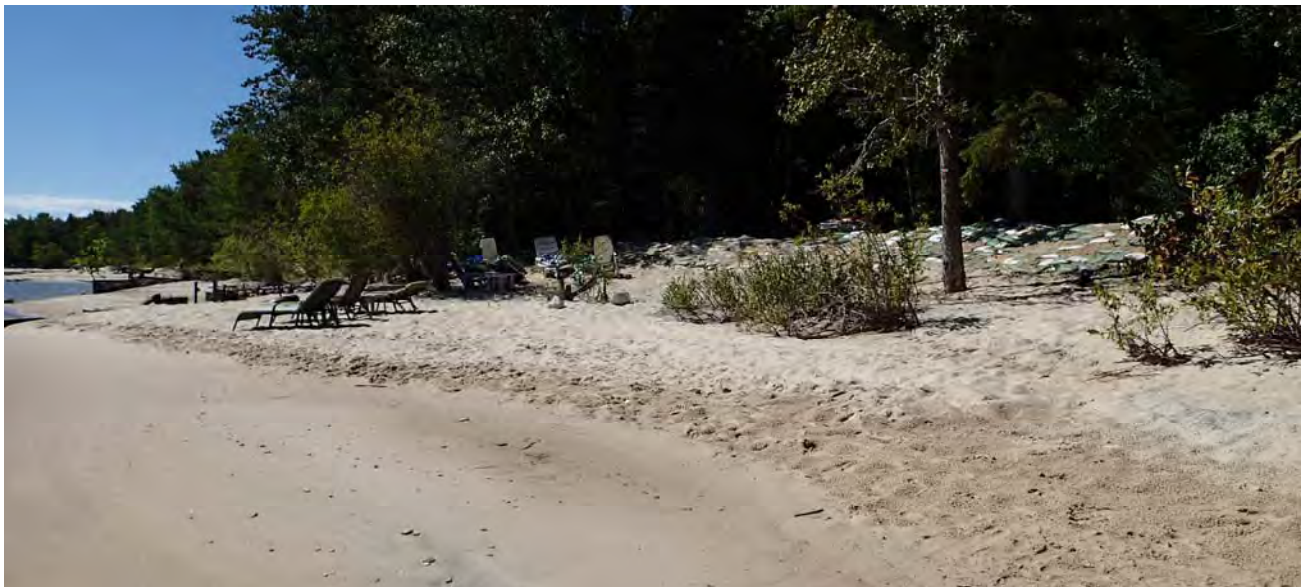
Figure 3.10 Example of Sand Bag Dyke along Albert Beach

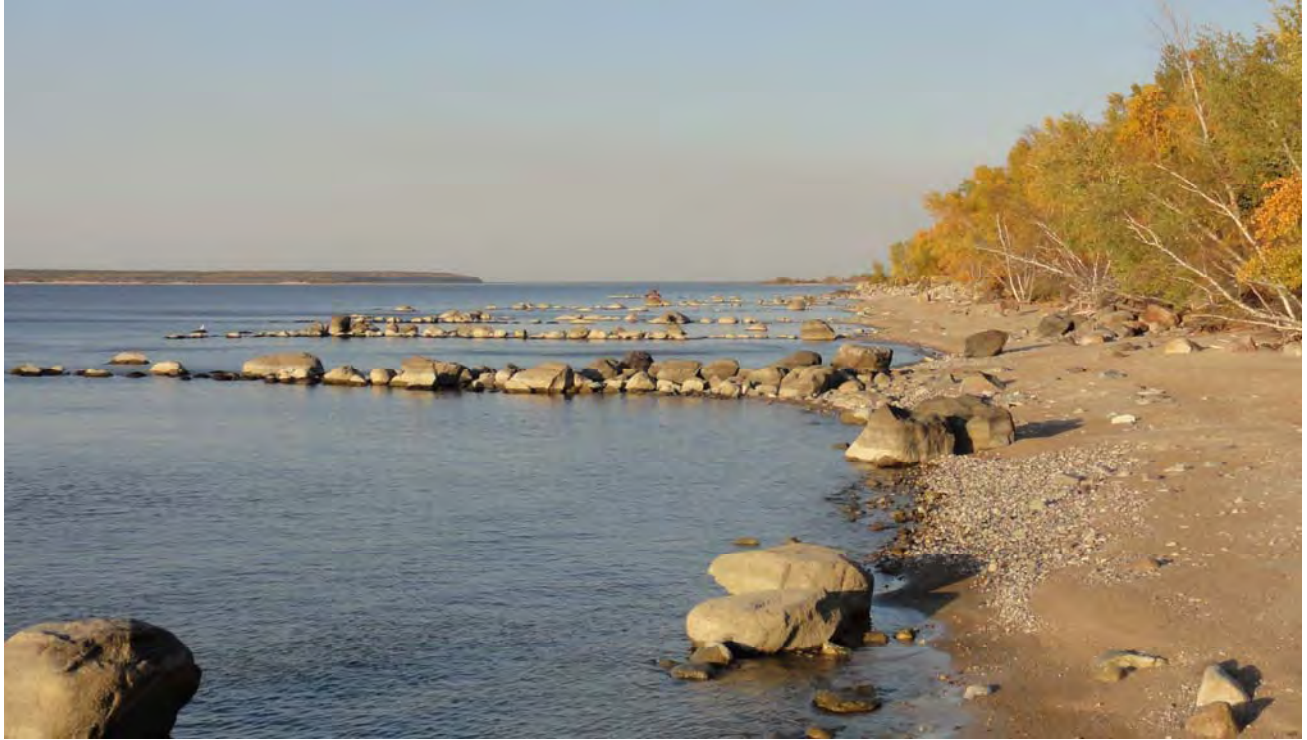
Figure 3.11 Example of Groynes (Connaught)

Shore perpendicular structures in the RMVB mainly consist of ad-hoc rock groynes, such as these constructed many years ago on Connaught Beach (refer to Figure 3.11). These groynes are now loosely packed, low crested, and are not effective at trapping sand or mitigating erosion.

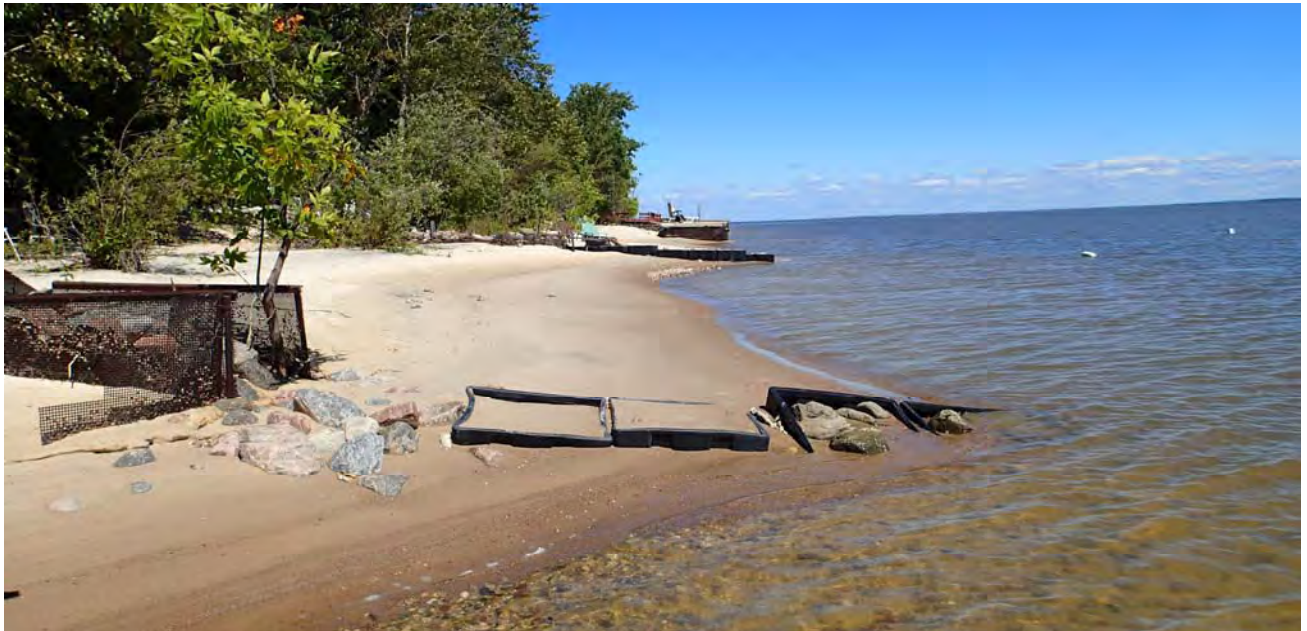
Figure 3.12 Example of Ad-Hoc Shore Perpendicular Structures along Wanasing Beach

A series of ad-hoc structures have been constructed on Wanasing Beach over the years and have been moderately successful at trapping sand due to the smaller wave heights found on this side of the peninsula. Refer to a typical structure in Figure 3.12.

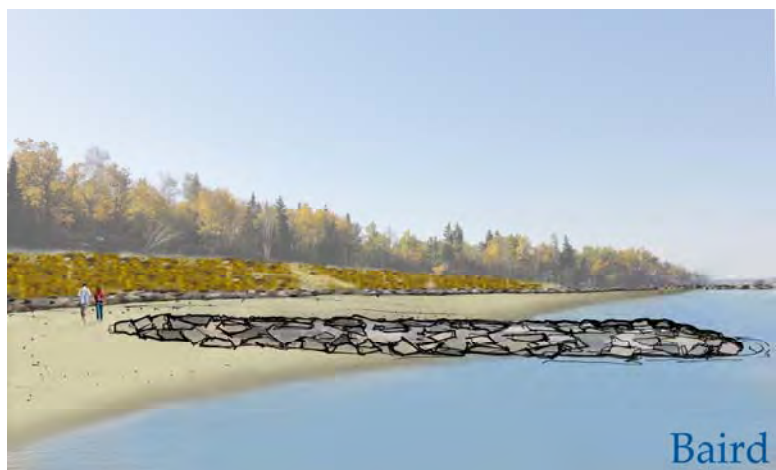
Figure 5.1 Example of Rock Groyne, Beach Nourishment, Toe Protection and Slope Re-grading and Vegetation

To stabilise the slope, it is recommended it is re-graded, vegetated and toe protection is used to reduce the bank erosion during high lake levels and storm events. In order to preserve the beach, it is important that the toe protection is done in conjunction a with beach nourishment program. Additional sand may be required in the future.

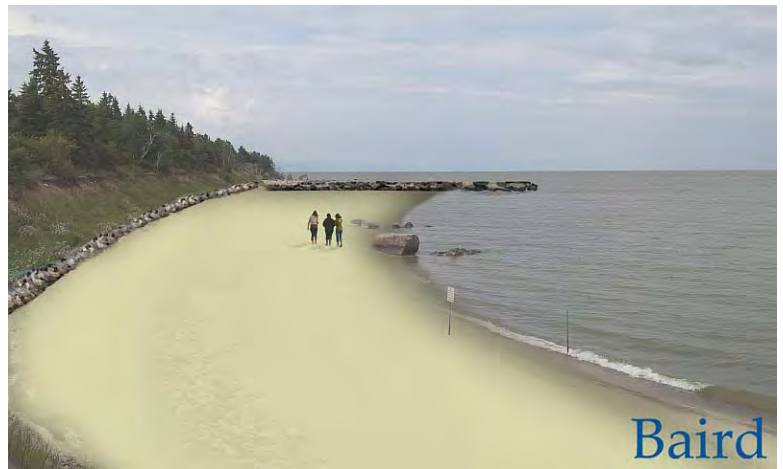
Figure 5.2 Example of Rock Groyne, Toe Protection and Slope Re-grading and Vegetation

Both King Edward and Alexandra are popular swimming beaches and waterfront homes are at high risk of damage. To enhance the beach and reduce the erosion threat to the homes, it is recommended that the beach is nourished and rock structures, either groynes or offshore breakwaters are used to anchor the sand and reduce the maintenance requirements over the design life. The location and number of structures required to anchor the beach nourishment will be determined during the design phase. A walkway will be maintained at the back of the beach to allow for easy pedestrian access. A schematic is provided in Figure 5.2 to illustrate how a rock groyne might be incorporated into the beach design. Figure 5.3 illustrates how an offshore breakwater can be incorporated into the design.

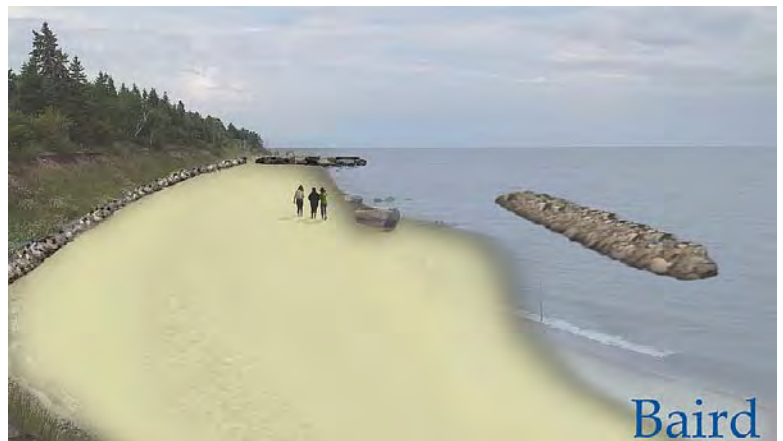
Figure 5.3 Example of Offshore Breakwater, Toe Protection and Slope Re-grading and Vegetation

To stabilise the slope, it is recommended it is re-graded, vegetated and toe protection is used to reduce the bank erosion during high lake levels and storm events. In order to preserve the beach, it is important that the toe protection is done in conjunction with beach nourishment that is maintained over time.

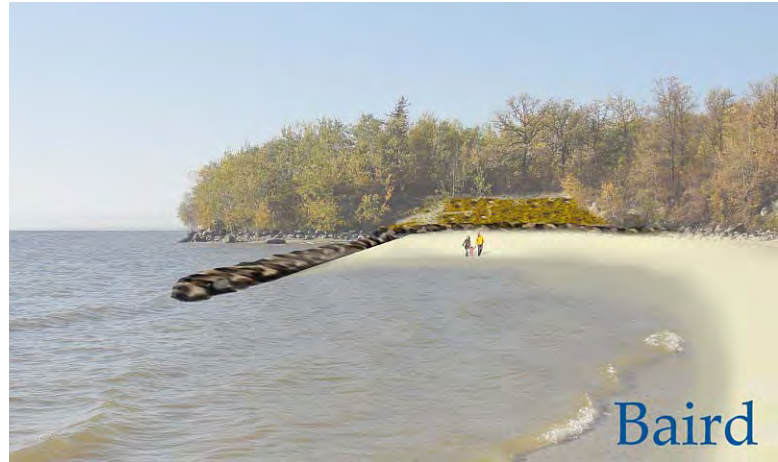
Figure 5.4 Example of Rock Groyne, Toe Protection and Slope Re-grading and Vegetation

The location and number of structures required to anchor the beach nourishment will be determined during the design phase. A walkway will be maintained at the back of the beach to allow for easy pedestrian access. A schematic is provided in Figure 5.4 to illustrate how a rock groyne might be incorporated into the beach design.

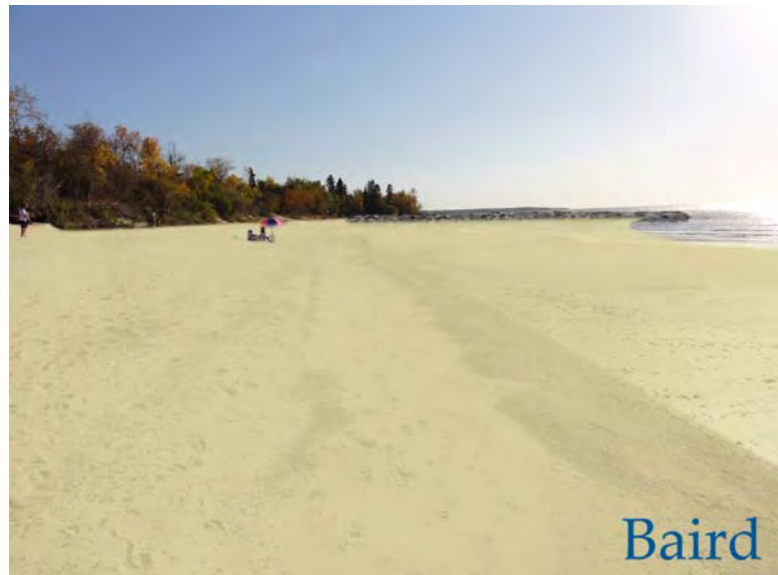
Figure 5.5 Example of Rock Groyne

This reach includes Clubhouse Beach, which is a popular swimming beach but is relatively wide and has been historically stable. It is recommended that the width of this beach is monitored and if erosion becomes a concern, then the beach can be enhanced with beach nourishment and a rock structure at the southern end of the reach, as shown schematically in Figure 5.5.

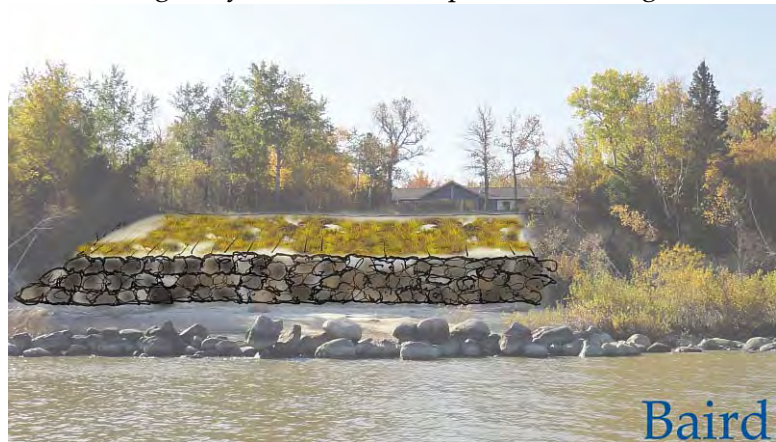
Figure 5.6 Example of Rock Revetment with Slope Re-grading and Vegetation

Once erosion threatens existing development, rock revetments are recommended with slope re-grading and planting of vegetation to reduce the amount of erosion during from overland runoff as shown in Figure 5.6.

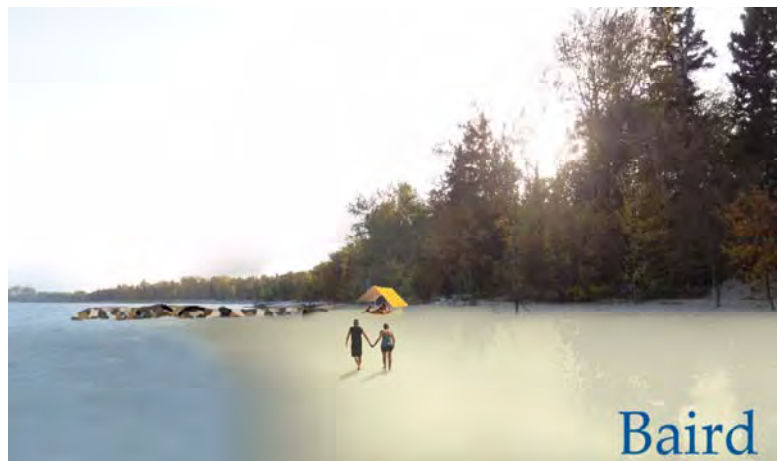
Figure 5.8 Example of Beach Nourishment with Rock Groyne

If bed erosion occurs in the future, it is recommended that the existing ad-hoc structures are removed and a uniform cohesive design be implemented as shown in Figure 5.8.

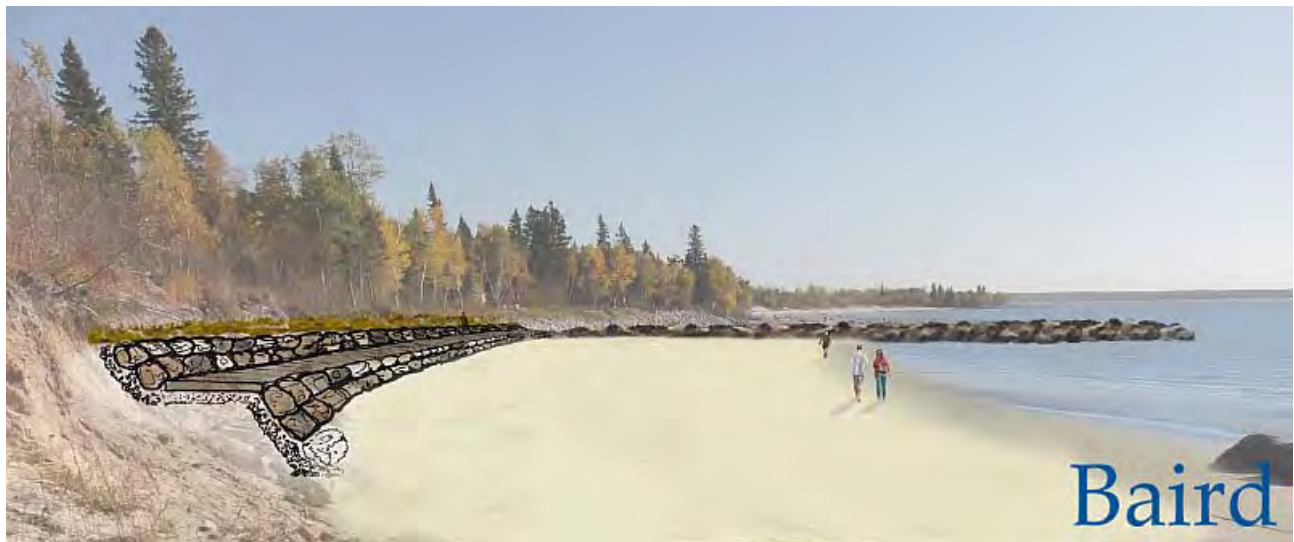
Additional structural elements can be incorporated into the beach design to enhance the recreational features, while providing extra protection for the sand cliffs and sand dunes from pedestrian traffic. Examples include a boardwalk incorporated into the toe protection as shown in Figure 5.9. A number of walkways along the top of the bluff have been eroded away, as an alternate a boardwalk made of natural material could be incorporated into the toe protection. The boardwalk could be tied into the stairs to maximize accessibility. Another example is a controlled access point to the beach as shown in Figure 5.10. This type of structure is suitable for sand dune areas, such as Club House Beach.

Figure 5.9 Example Boardwalk Incorporated into Toe Protection

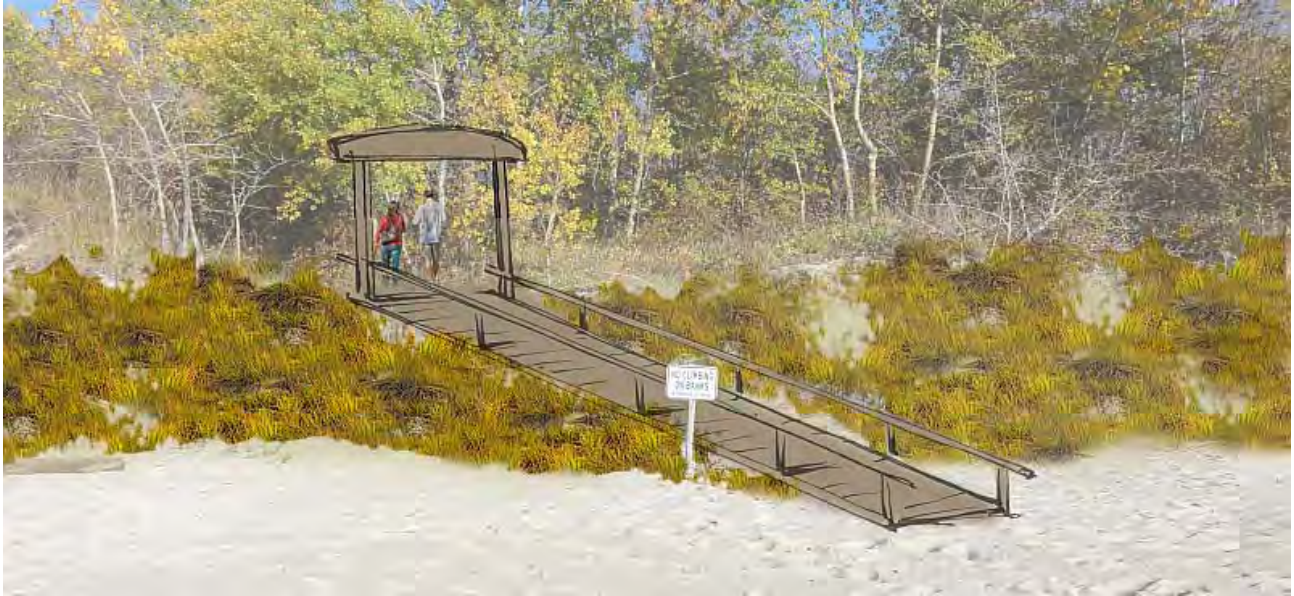
Figure 5.10 Example of Controlled Beach Access Point and Slope Re-grading and Vegetation

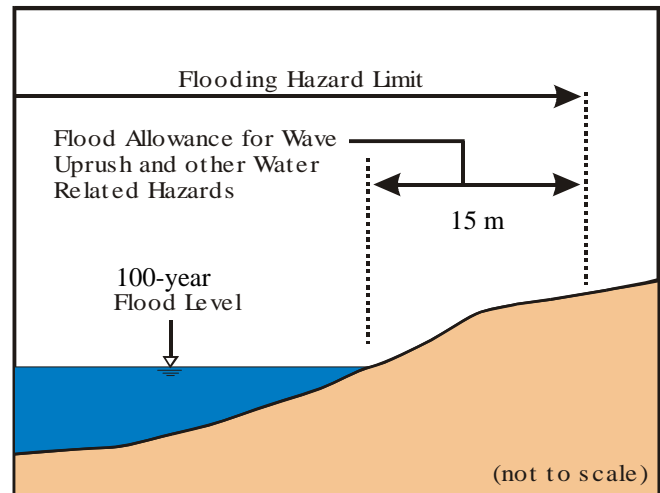
Figure 6.1 Flooding Hazard Limit with Wave Uprush

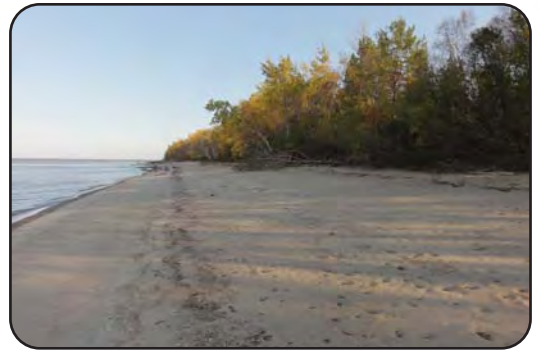
AERIAL IMAGERY (2011)

- LOW SANDY BLUFF
- COASTAL FLOOD PLAIN WITH STABLE SANDY BEACH
- ROCK REVETMENT (SOUTH EAST SHORE)
- BURIED FLOOD DYKE AT BACK OF BEACH
- RANDOMLY PLACED ROCK PILES
