Rural Municipality of Victoria Beach Shoreline Management Plan Lake Winnipeg, Manitoba

February 7, 2014
11930.201

Rural Municipality of Victoria Beach Shoreline Management Plan

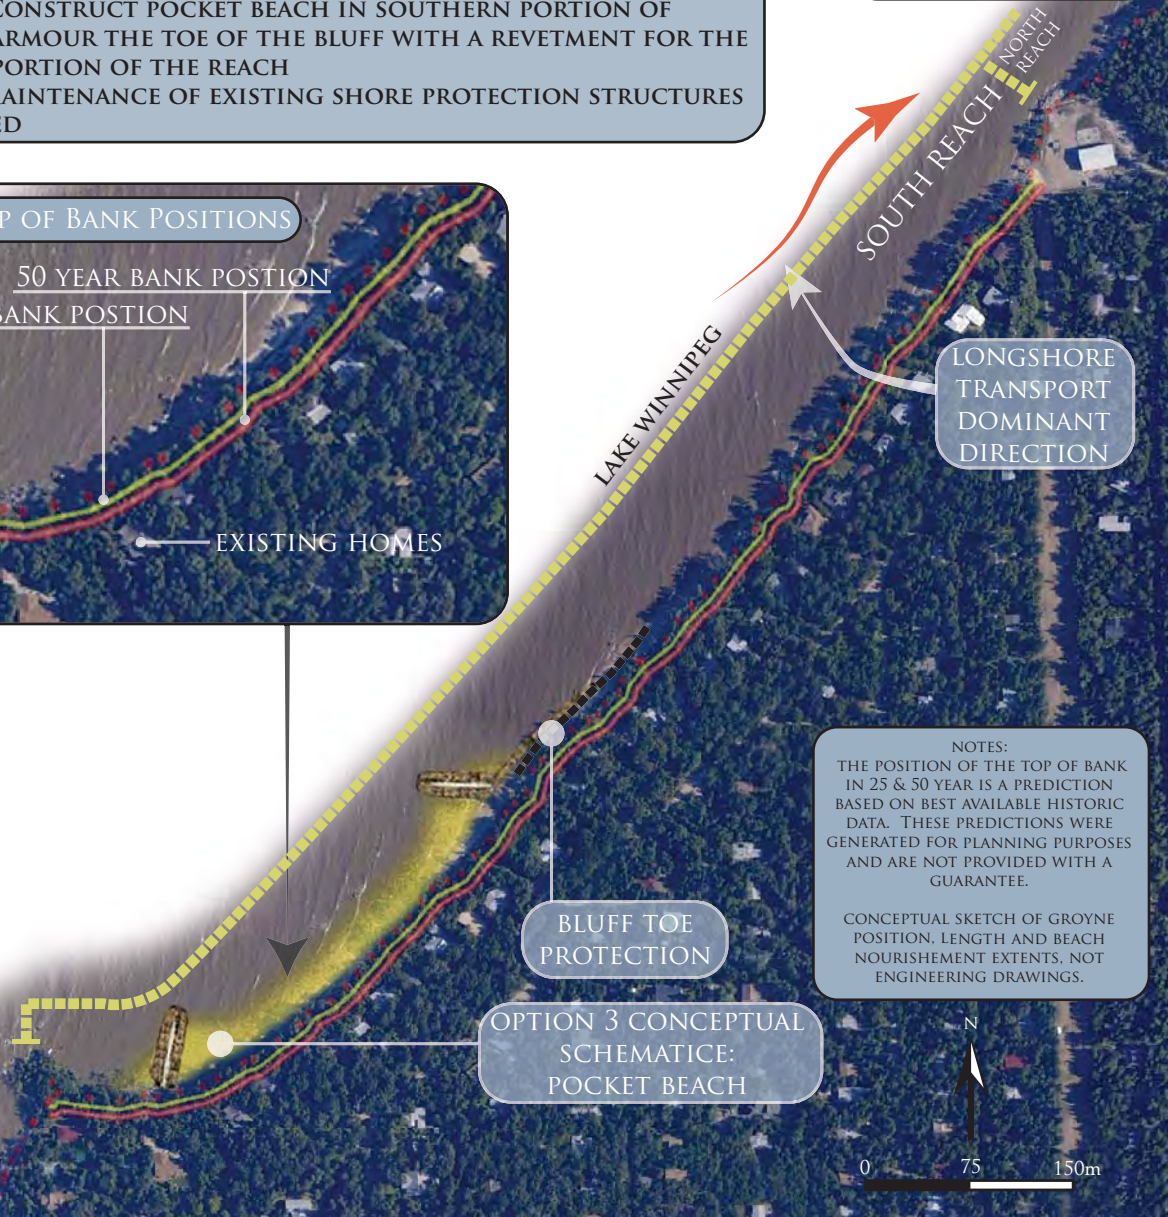
NOTES:
THE POSITION OF THE TOP OF BANK IN 25 & 50 YEAR IS A PREDICTION BASED ON BEST AVAILABLE HISTORIC DATA. THESE PREDICTIONS WERE GENERATED FOR PLANNING PURPOSES AND ARE NOT PROVIDED WITH A GUARANTEE.

CONCEPTUAL SKETCH OF GROYNES POSITION, LENGTH AND BEACH NOURISHMENT EXTENTS, NOT ENGINEERING DRAWINGS.

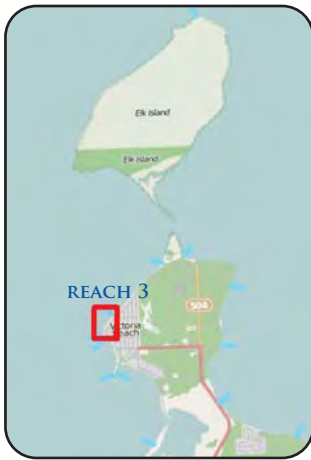
OPTION 2 CONCEPTUAL SCHEMATIC: ROCK GROUYNE WITH NOURISHMENT TO ENHANCE BEACHES WITH LOW MAINTENANCE

- OPTION 1: BEACH NOURISHMENT WITH PERIODIC MAINTENANCE
- OPTION 2: GROYNES AND BEACH NOURISHMENT (GROYNES ANCHOR THE NOURISHMENT AND REDUCE THE AMOUNT OF MAINTENANCE REQUIRED)
- OPTION 3: ARMOUR BLUFF TOE WITH ROCK REVETMENT (BEACH WILL EVENTUALLY DISAPPEAR)

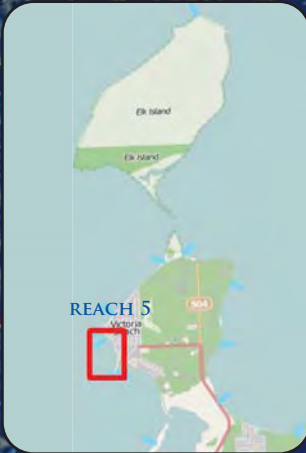
OPTION 3 CONCEPTUAL SCHEMATIC: ENHANCE PATRICIA & ARTHUR BEACH USING ROCK GROYNES & BEACH NOURISHMENT

- OPTION 1: CONTROL PEDESTRIAN TRAFFIC THROUGH SIGNAGE AND WALKWAYS CONSTRUCTED OUT OF NATURAL MATERIALS SUCH AS WOOD AND VEGETATION
- OPTION 2: BEACH NOURISHMENT AT PATRICIA AND ARTHUR WITH PERIODIC MAINTENANCE
- OPTION 3: GROYNES AND BEACH NOURISHMENT AT PATRICIA & ARTHUR (GROYNES ANCHOR THE NOURISHMENT AND REDUCE THE AMOUNT OF MAINTENANCE REQUIRED)
- OPTION 4: ARMOURING BLUFF TOE WITH ROCK REVETMENT AT PATRICIA & ARTHUR (THE BEACH WILL EVENTUALLY DISAPPEAR) AND CONSTRUCT GROYNE SOUTH OF CLUBHOUSE TO ENHANCE CLUBHOUSE BEACH

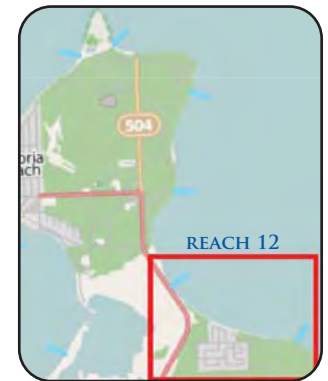
LOCATION OF PROPOSED NEW PARKING LOT AS PART OF OPTION 2 FOR ALBERT BEACH ACCESS AND TO CONTROL TRAFFIC

- OPTION 1: ENFORCE FLOOD PROOFING MEASURES FOR LOW LYING AREAS SUBJECT TO FLOODING RISK DURING HIGH LAKE LEVELS
- OPTION 2: CONTROL CAR TRAFFIC WITH MUNICIPAL PARKING LOT FOR BEACH ACCESS

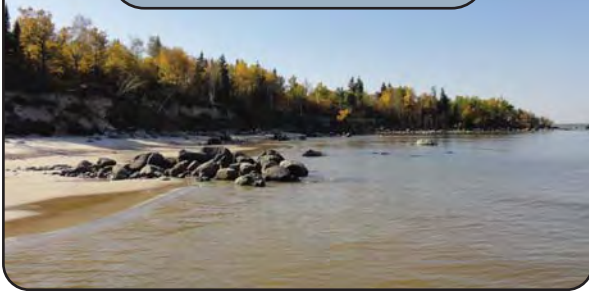
REACH 2: SOUTH
CONCEPTUAL SKETCH OF ROCK GROYPNE, BEACH NOURISHMENT & TOE/SLOPE PROTECTION

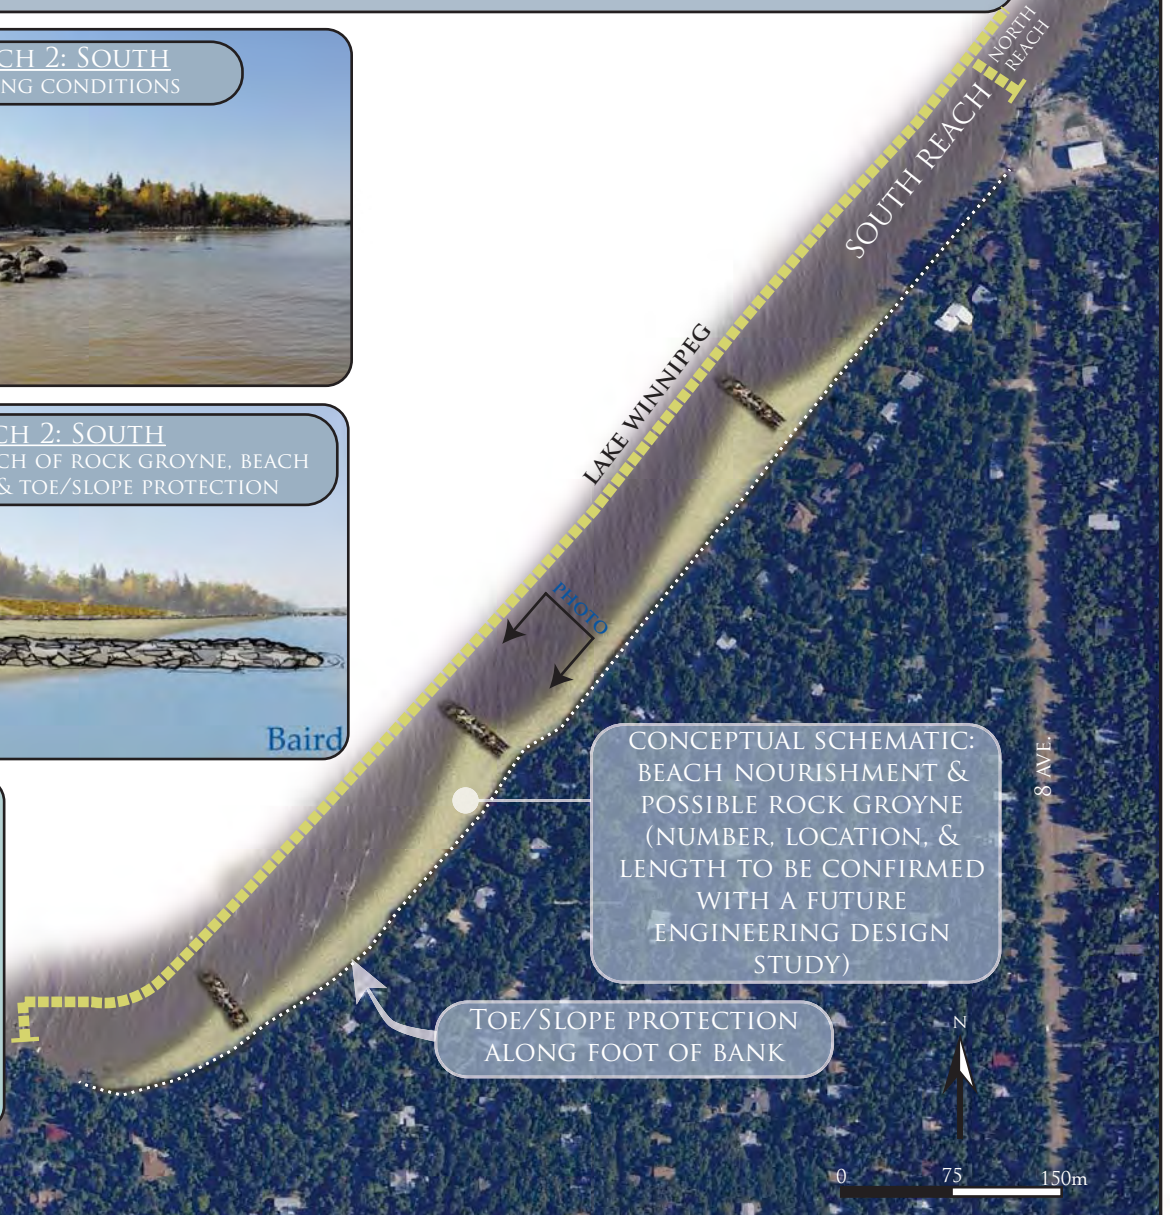
CONCEPTUAL SCHEMATIC:
BEACH NOURISHMENT &
POSSIBLE ROCK GROYPNE
(NUMBER, LOCATION, &
LENGTH TO BE CONFIRMED
WITH A FUTURE
ENGINEERING DESIGN
STUDY)

TOE/SLOPE PROTECTION
ALONG FOOT OF BANK

- COMMENCE FINAL ENGINEERING TO DETERMINE DESIGN PARAMETERS AND OPTIMIZE DESIGN
- RECOMMENDED DESIGN INCLUDES BEACH NOURISHMENT & TOE PROTECTION FOR BANK.
- ROCK STRUCTURES IN THE FORM OF GROYNES OR OFFSHORE BREAKWATERS WILL BE REQUIRED (SEE CONCEPTUAL SKETCH) TO ANCHOR THE SAND (NUMBER AND LOCATION TO BE CONFIRMED DURING ENGINEERING DESIGN)

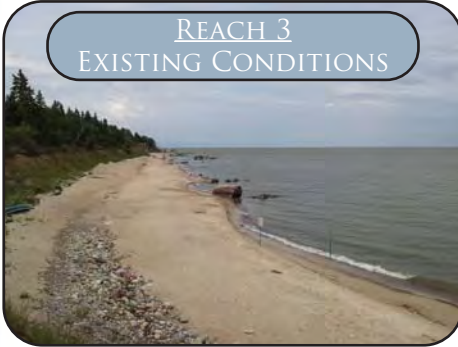
REACH 3
CONCEPTUAL SKETCH OF BEACH
ENHANCEMENT

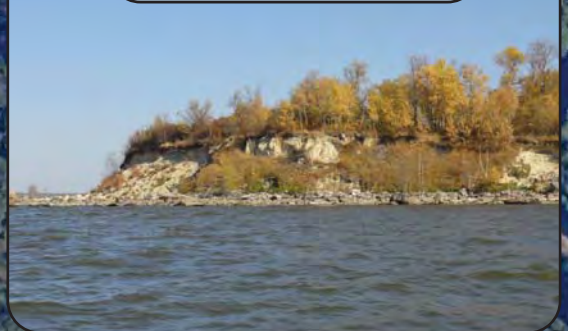
REACH 4
CONCEPTUAL SKETCH

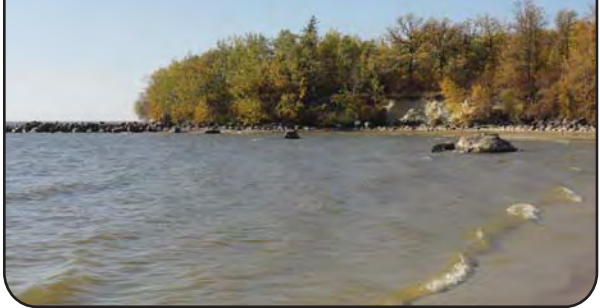
REACH 5 EXISTING CONDITIONS

EXISTING ROCK REVETMENT

REVETMENT (NEW)

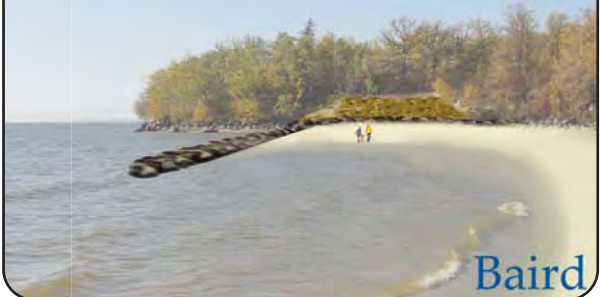
REACH 5 CONCEPTUAL SKETCH

UPGRADE TOE PROTECTION AS REQUIRED

OLDER ROCK REVETMENT

VEGETATION

- COMMENCE FINAL ENGINEERING TO DETERMINE DESIGN PARAMETERS AND OPTIMISE DESIGN.
- RECOMMENDED DESIGN INCLUDES BEACH NOURISHMENT & TOE PROTECTION FOR BANK.
- SLOPE REGRADING AND VEGETATION IS ALSO RECOMMENDED.
- ROCK STRUCTURES IN THE FORM OF GROYNES OR OFFSHORE BREAKWATERS WILL BE REQUIRED (REFER TO CONCEPTUAL SKETCH) TO ANCHOR SAND (LENGTH AND LOCATION TO BE CONFIRMED WITH ENGINEERING DESIGN STUDY).

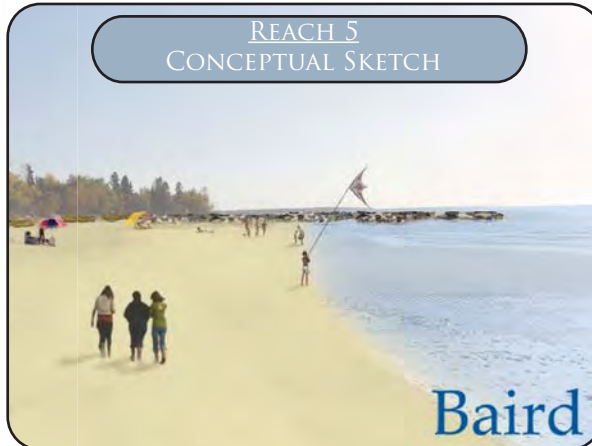
REACH 5
CONCEPTUAL SKETCH

- MONITOR EROSION OF DUNES
- IF EROSION CONTINUES, CONSIDER BEACH NOURISHMENT AND CONSTRUCTING A GROYPNE AT SOUTHERN END OF BEACH (REFER TO CONCEPTUAL SKETCH).

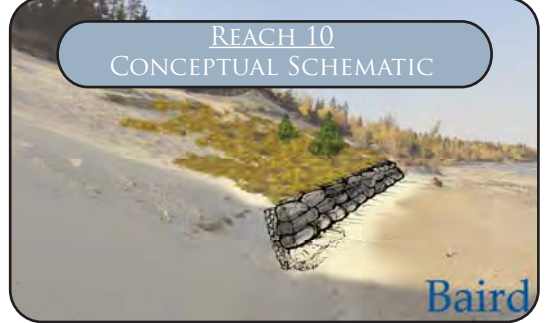
REACH 10
CONCEPTUAL SCHEMATIC

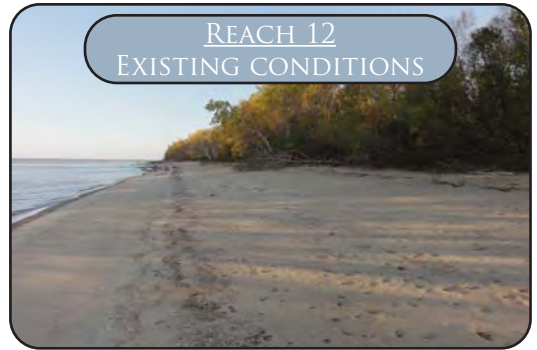
REACH 12
EXISTING CONDITIONS

- 2013 TOP OF BANK SURVEY IS WITHIN 2 METRES OF THE LAKEWARD EDGE OF ABOUT 30% OF THE PRIVATE PROPERTY PARCELS AND THE REMAINING PARCELS ARE GREATER THAN 5 METRES. THIS REACH IS AT LOW RISK OF THE SHORELINE ERODING TO THE PROPERTY PARCELS.

- EVALUATE STATE AND ELEVATION OF THE SAND BAG DYKE TO SEE IF IT PROVIDES ADEQUATE PROTECTION; IF NOT, REPAIR.
- CONSTRUCT PARKING LOT FOR ALBERT BEACH ACCESS (OPTIONAL).
