Victoria Beach Field Observations and Recommendations Lake Winnipeg, Manitoba

December 12, 2011
11930.101

Rural Municipality of Victoria Beach

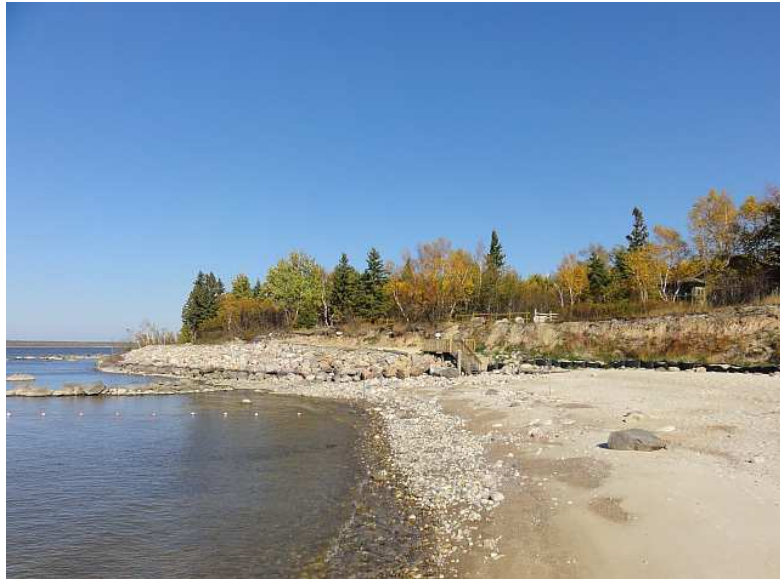
King Edward Beach is located along the west shore of the RMVB and the beach is accessed from a wooden stairwell. See Figure 3.4. The headland to the north of the staircase was armoured in the past and was just recently upgraded with additional stone. Along the toe of the eroding sand bank at King Edward, geo-textile sand bags were placed to provide temporary protection from bank erosion during high lake levels.

Figure 3.4 Staircase to King Edward Beach

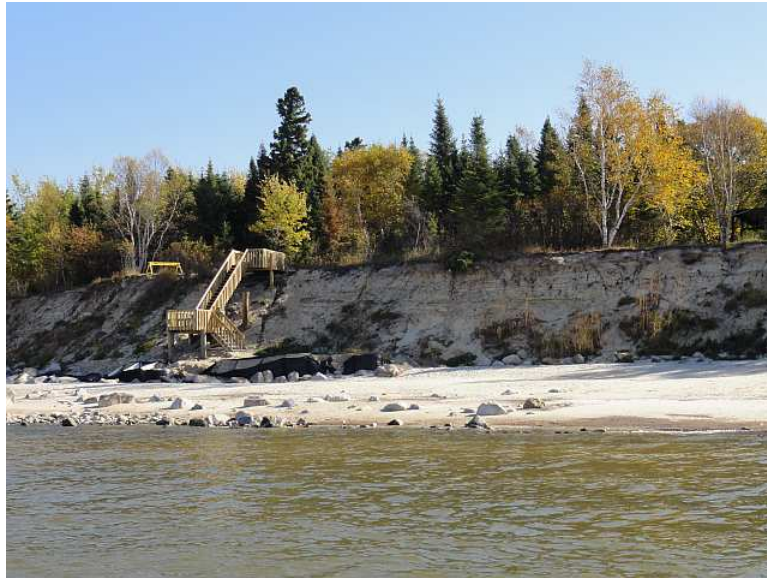
Alexandra Beach is adjacent to King Edward and access to the beach from the high sand bank is provided by a wooden staircase (Figure 3.6). The base of the staircase was also protected with the geo-textile sand bags. In several locations large boulders have been rearranged to form ad hoc shore perpendicular shore protection, such as the groyne in Figure 3.7.

Figure 3.6 Stairwell to Alexandra Beach

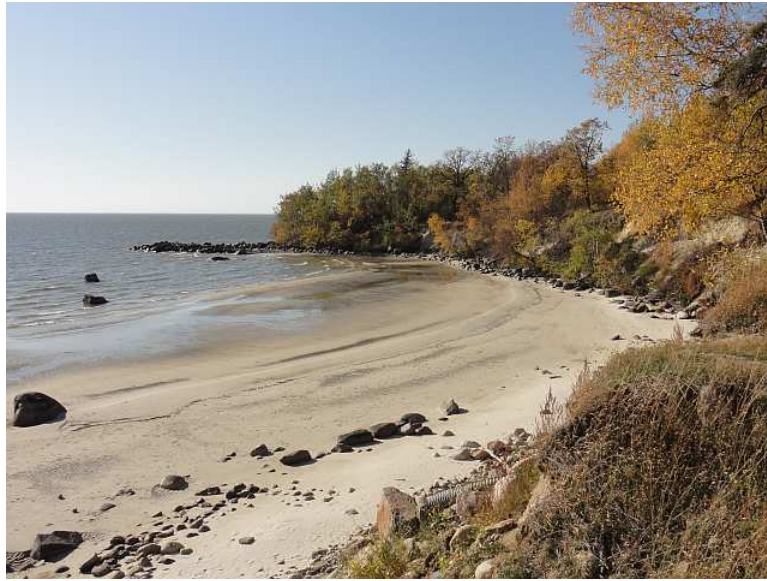
Patricia Beach is located at the base of a high eroding sand bank. The northern limits of the beach are seen in Figure 3.8. A groyne type structure was installed in the past and it appears some ad hoc shore protection is located at the back of the beach. The beach features a very gentle slope and a wide swath of the nearshore was exposed in Figure 3.9 on October 5, 2011 due to the offshore winds and setdown of the lake surface.

Figure 3.8 Patricia Looking to the North-west

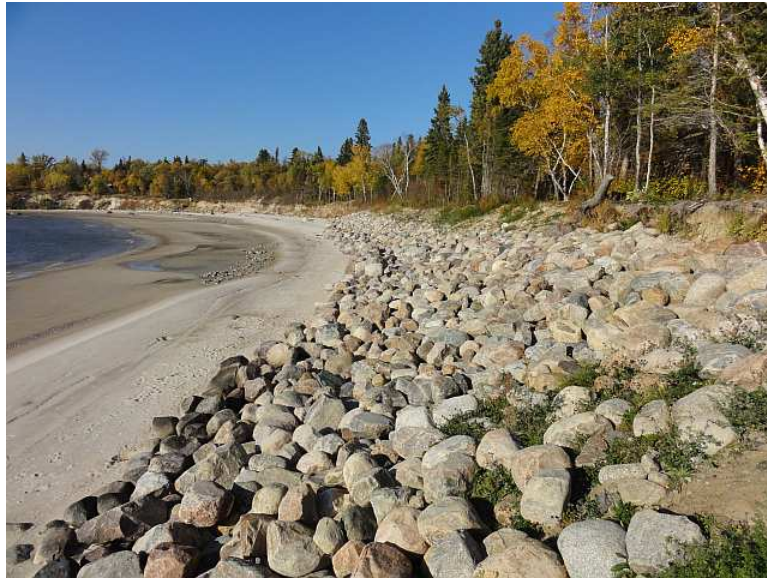
A revetment was recently constructed at the toe of the eroding bank at Arthur Beach, as seen in Figure 3.10. The transition from the revetment to the natural sand bank is seen from the water in Figure 3.11. Remnants of former shore protection was observed further south.

Figure 3.10 Recent Revetment Constructed at the Back of the Beach (Arthur)

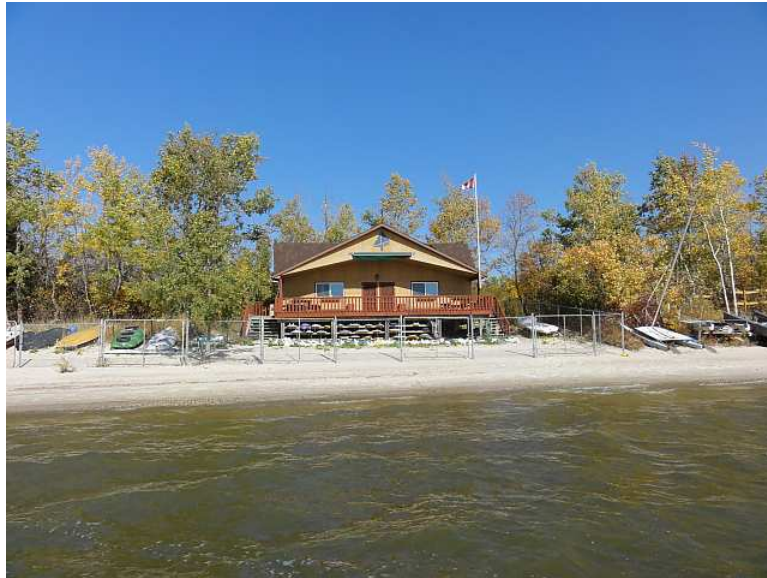
Bayview is located in the lee of the municipal pier and features a narrow sand beach. A boating club is located on the beach, as seen in Figure 3.14. The sand beach transitions to shore protect towards the pier, as noted in Figure 3.15. Although the beach is somewhat sheltered from wave attack on the main lake, sediment supply is also limited due to the presence of the pier.

Figure 3.14 Boat Club at Bayview

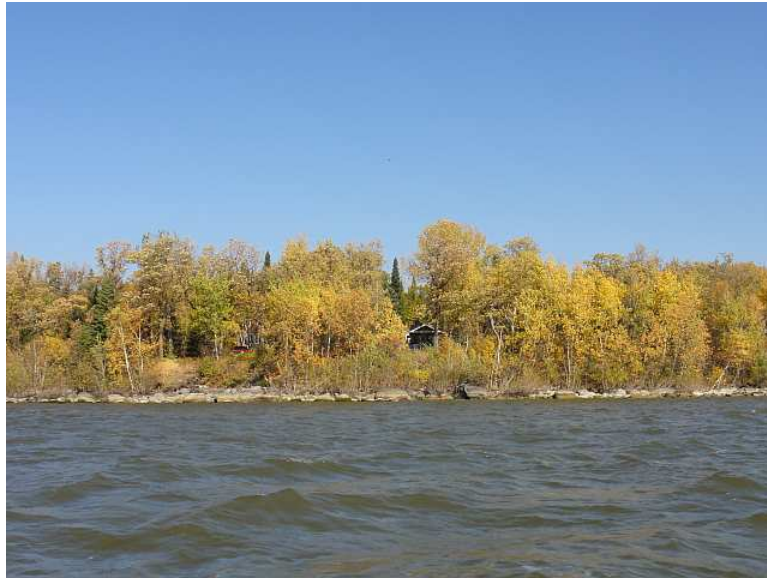
The Thornton Boulevard reach features a combination of natural shoreline conditions with dense backshore vegetation and engineered shore protection and buildings within close proximity to the shoreline. Beaches were generally absent in this reach with the early October, 2011 lake levels.

Figure 3.16 Natural Shoreline Along Thornton Boulevard

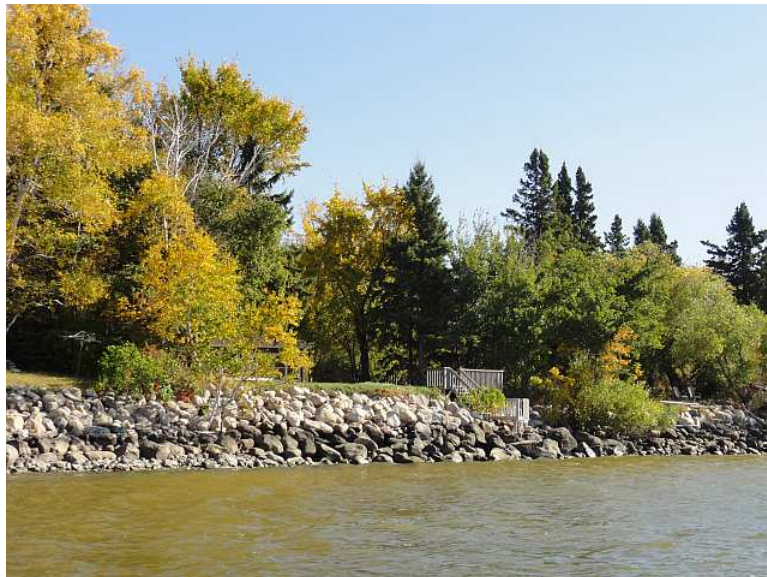
Figure 3.17 Shore Protection Along Thornton Beach

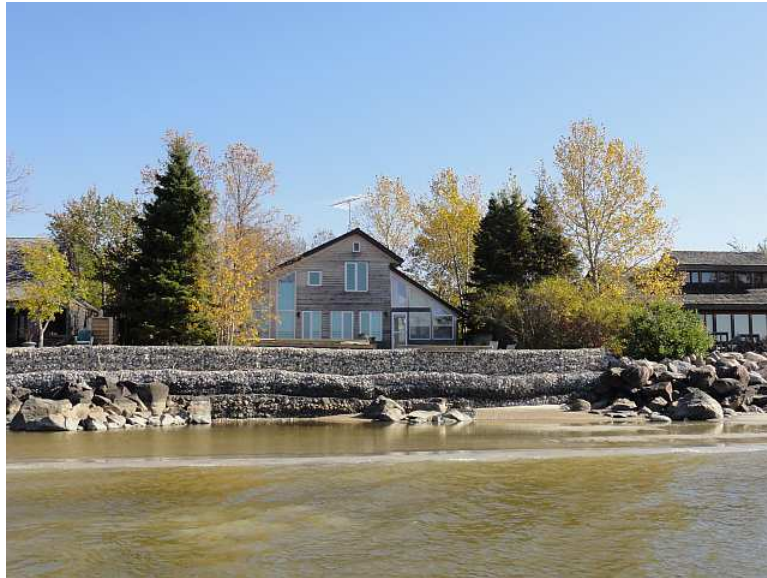
Pelican Point is a relatively recent development that was constructed on top of a former barrier beach. The homes are all located in very close proximity to the shoreline and heavily protected. The first generation of protection appears to be large boulders, which were followed recently by gabion baskets in select locations. Refer to Figure 3.18 and 3.19.

Figure 3.18 Gabion Basket Shore Protection at Pelican Point

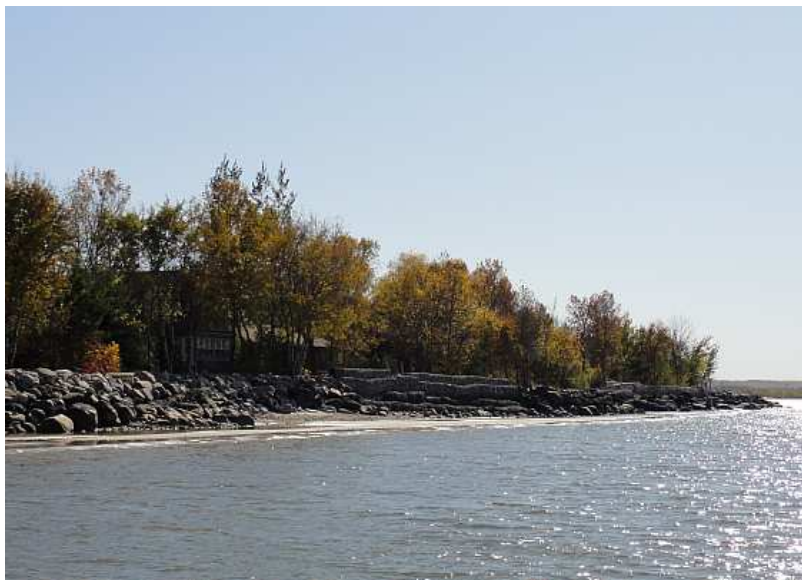
Figure 3.19 Rock and Gabion Protection at Pelican Point

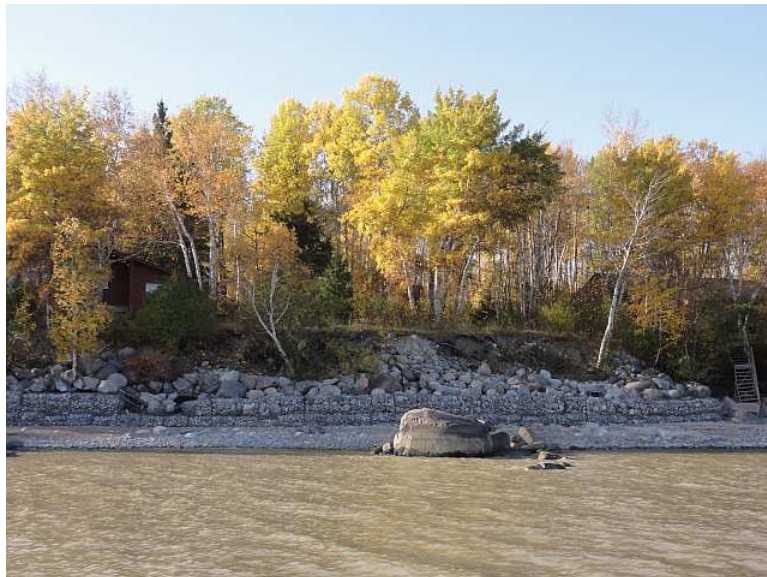
The south-east boundary of the municipality is defined by Saffie Road. The eroding bluffs appear to cut in a glacial till with a high cobble/boulder content and low percentage of sand. Refer to Figure 3.20. The backshore is protected by a combination of dumped boulders and gabion baskets. Given the general shoreline orientation of this area and lack of sand in the bank, it is unlikely sand beaches exist here, even during low lake levels.

Figure 3.21 Dumped Boulders and Gabion Basket Protection

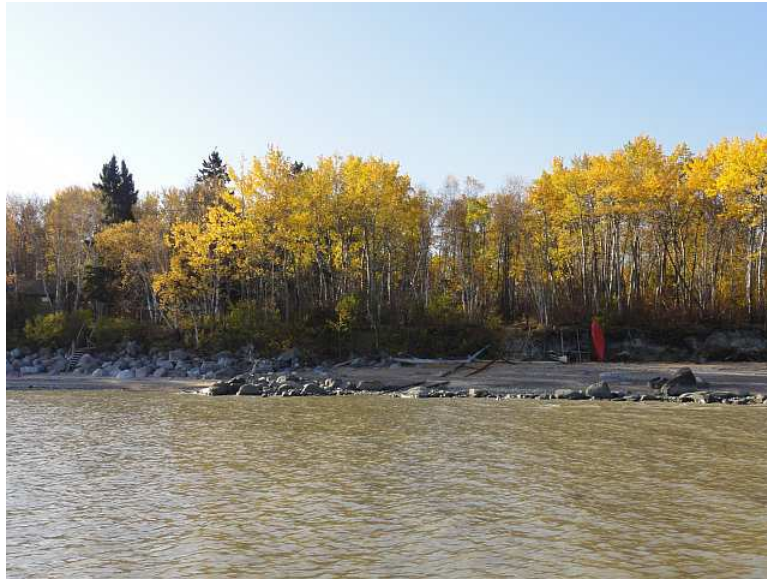
Albert Beach is located north-west of Saffie Road and is generally unprotected. The bank height decreases as you move towards the causeway. Since the back of the beach has remained unprotected, a wide beach remains. Refer to Figure 3.22. Due to the low elevation of the backshore, a sand bank dyke was constructed at the back of the beach to protect the residential/cottage development.

Figure 3.22 Transition from Armoured Saffie Road to Unprotected Albert Beach

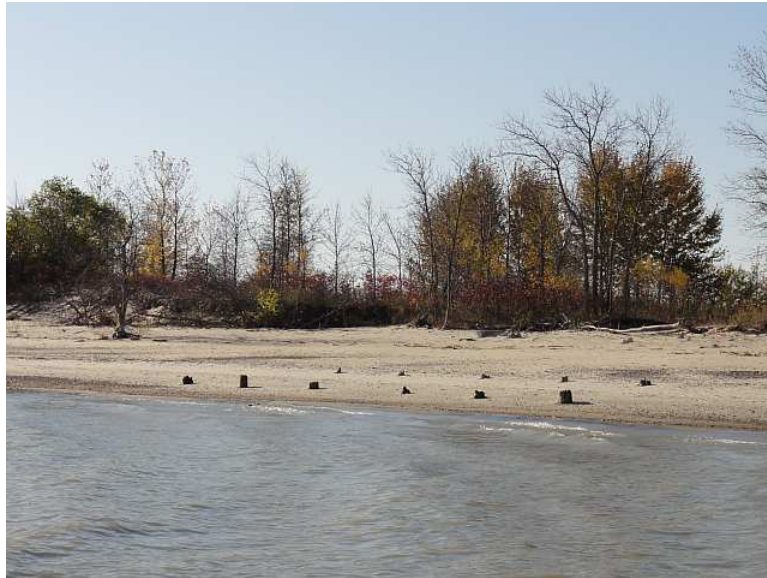
The Causeway is a narrow strip of beach that separates Lake Winnipeg from Highway 59. Although this area features a sand beach, the shoreline has been heavily modified by structures in the past. Refer to the former piles in Figure 3.24 from a former Lumber Mill. Exposed tree roots in the backshore, as seen in Figure 3.25, suggest the beach is eroding.

Figure 3.24 Piles from a former Lumber Mill

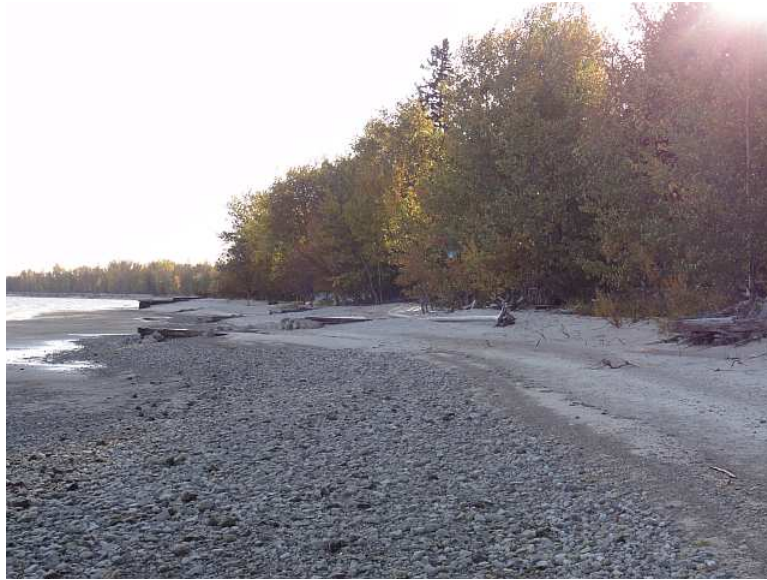
Wanasing features a combination of sand and cobble/pebble beaches. See Figure 3.26. Due to the low elevations of the backshore, a sand bag dyke was recently constructed to provide additional flood protection (Figure 3.27). The beach features a wide variety of structures, from boulder groynes, gabion groynes and boat docks.

Figure 3.26 Sand and Cobble Beach at Wanasing

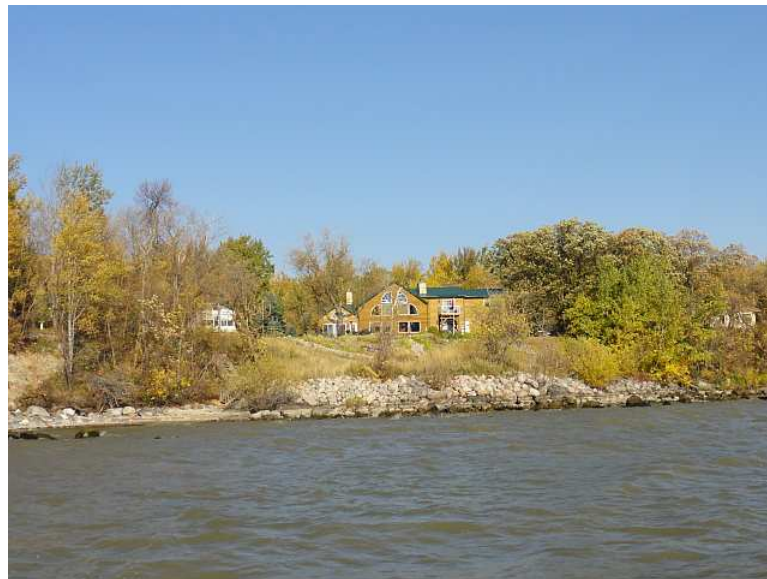
Sunrise features similar geologic conditions (very high sandy bluffs) to Sand Bluffs. It was distinguished as a separate study area due to the presence of the residential development as seen in Figure 3.30. It appears a large rotational failure also impacted this stretch of shore and future slope failures might have serious consequences for the existing development. A bluff stability assessment should be performed to evaluate the risks of future failures. Some areas are protected (Figure 3.31).

Figure 3.31 Shore Protection at Sunrise

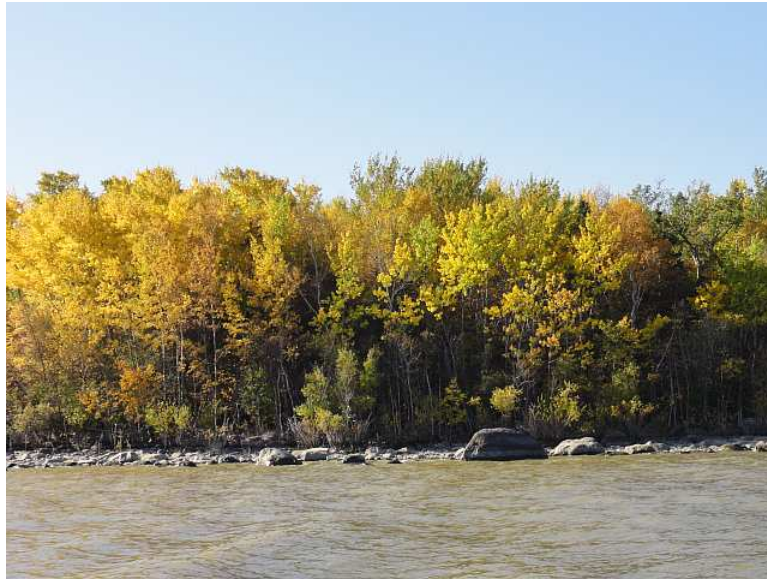
The Hampton peninsula is located in the north-east corner of the municipality. Development densities are not as dense as most other shoreline segments. Although the shoreline orientation is not conducive to beach building, the natural sections of shore are stable (see Figure 3.32). Conversely, when the forest vegetation has been removed for development, a steep eroding bank is present at the back of the beach, as seen in Figure 3.33.

Figure 3.32 Natural Shoreline with Stable Backshore

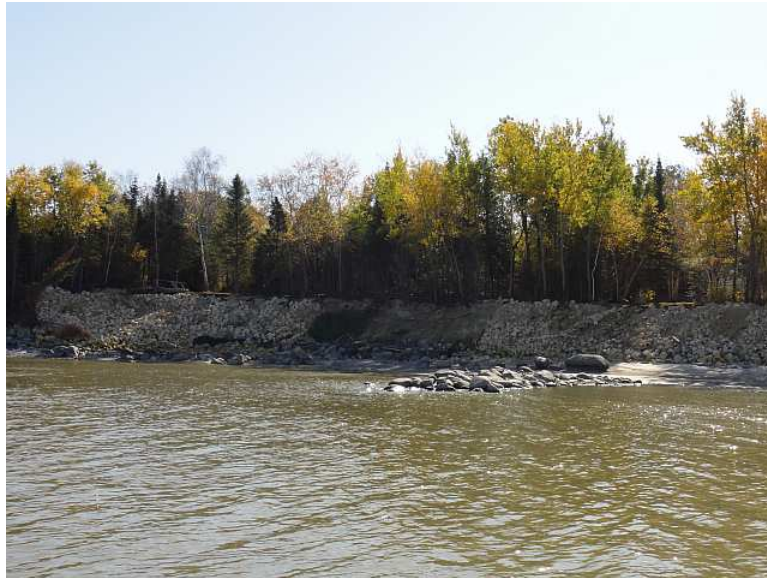
Highway 504 terminates along the north shore of the municipality. Recently, a large volume of stone was placed at the back of the beach. Refer to Figure 3.34. A cut down the bank provides access to the beach for launching boats. For example, our survey vessel was launched from the tractor seen in Figure 3.35.

Figure 3.34 Recent Bank Protection at the Termination of Highway 504

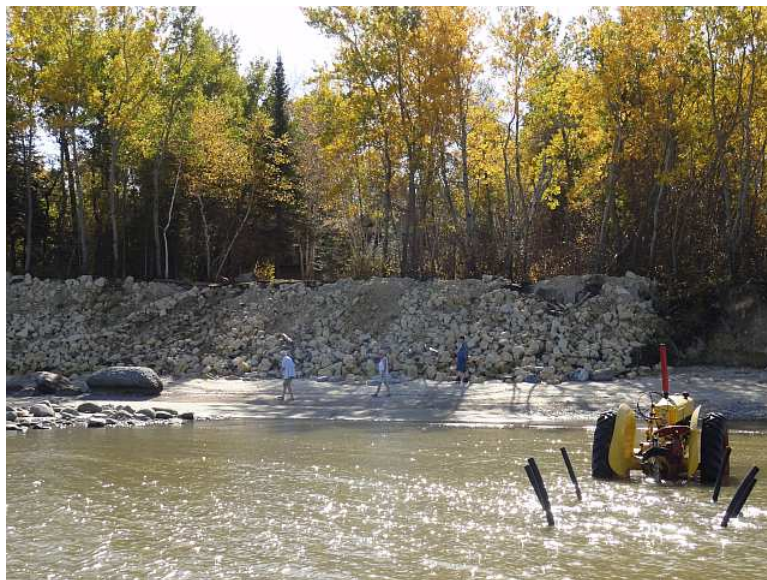
Figure 3.35 Close Up of Recent Bank Protection

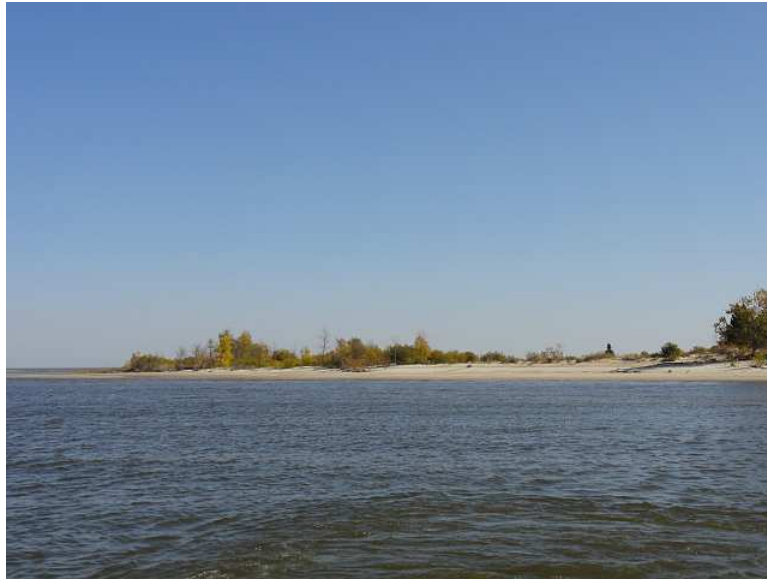
Elk Island Provincial Park is located north of the RMVB. A small portion is located on the mainland at the northern tip of the municipality. The vegetated tip of the park is seen in Figure 3.36. A sand spit extends further to the north and the degree of exposure for this dynamic sand feature will be determined by lake levels, storm surges and sediment supply. The eastern and western shores of the park feature sandy beaches backed by sand dunes (Figure 3.37).

Figure 3.36 North Facing Tip of Elk Island Provincial Park (connected to mainland)

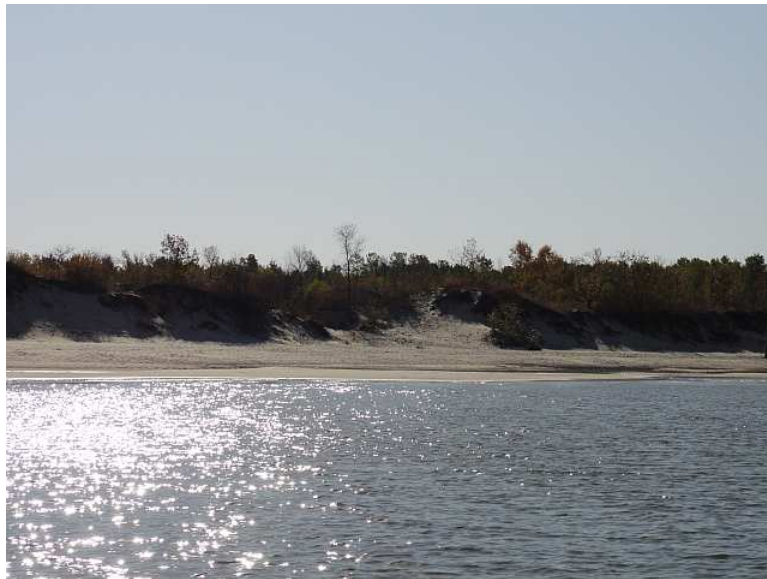
Figure 3.37 Beach and Dunes along the Western Shore of the Provincial Park (connected to mainland)

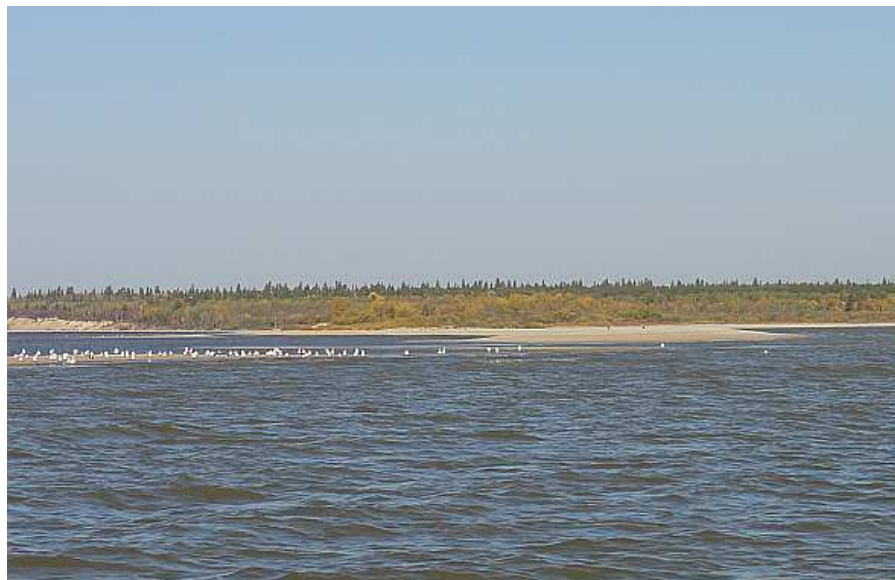
The southern shoreline of Elk Island Provincial Park and the sand spit were observed from the boat. A view of the south-west shoreline is seen in Figure 3.38 and it looks very similar to the Sand Bluffs site. This eroding sand bluff is a potential source of beach sand for the western shore of the RMVB. The sand spit at the southern tip of the island is a popular locations for shore birds (see Figure 3.39).

Figure 3.39 Sand Spit Extending Southward from Elk Island
